Alderley Edge Restoration of a Late Victorian Encaustic & Geometric Tiled Floor.

The Victorian encaustic & geometric tiled floor on this contract was badly damaged in a number of areas most notably at the foot of the stairs.

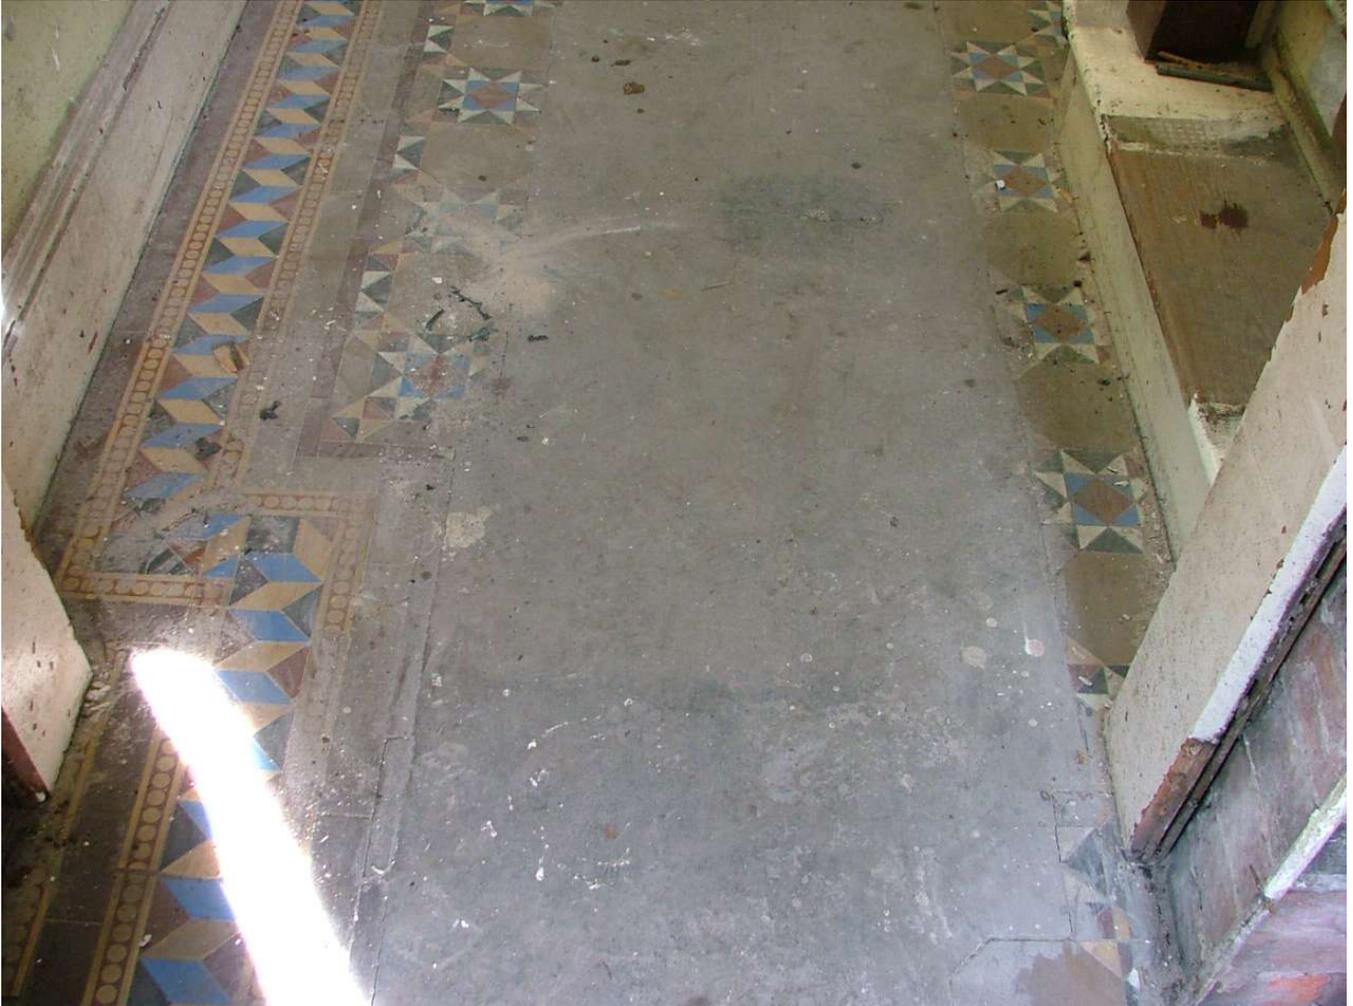
This section of damage is over 6 feet long (180 cm) the in-fill is concrete.

I used Exakt saws 3 in rotation to cut around the existing tiles this then allowed me to remove the first layer of infill which was a concrete mix, I used a small Makita hammer drill with a blade chisel attachment to chop out between lines cut with the Exakt saw diamond blades, I took out all the infill down to the original Victorian base which comprised of a rough lime screed sloppy mix with the usual muck that the original builders nearly always throw into the base screed of what will be a tiled floor, in the first rough screed here we found lead scraps from the leaded glass fitters, clay pipe bowls & broken stems, plenty of pipe dottle (the smoked content of a pipe bowl) horse manure, bits of wood, nails, debris from brushing up around the work place. Foundry slag which must have been used as hardcore.

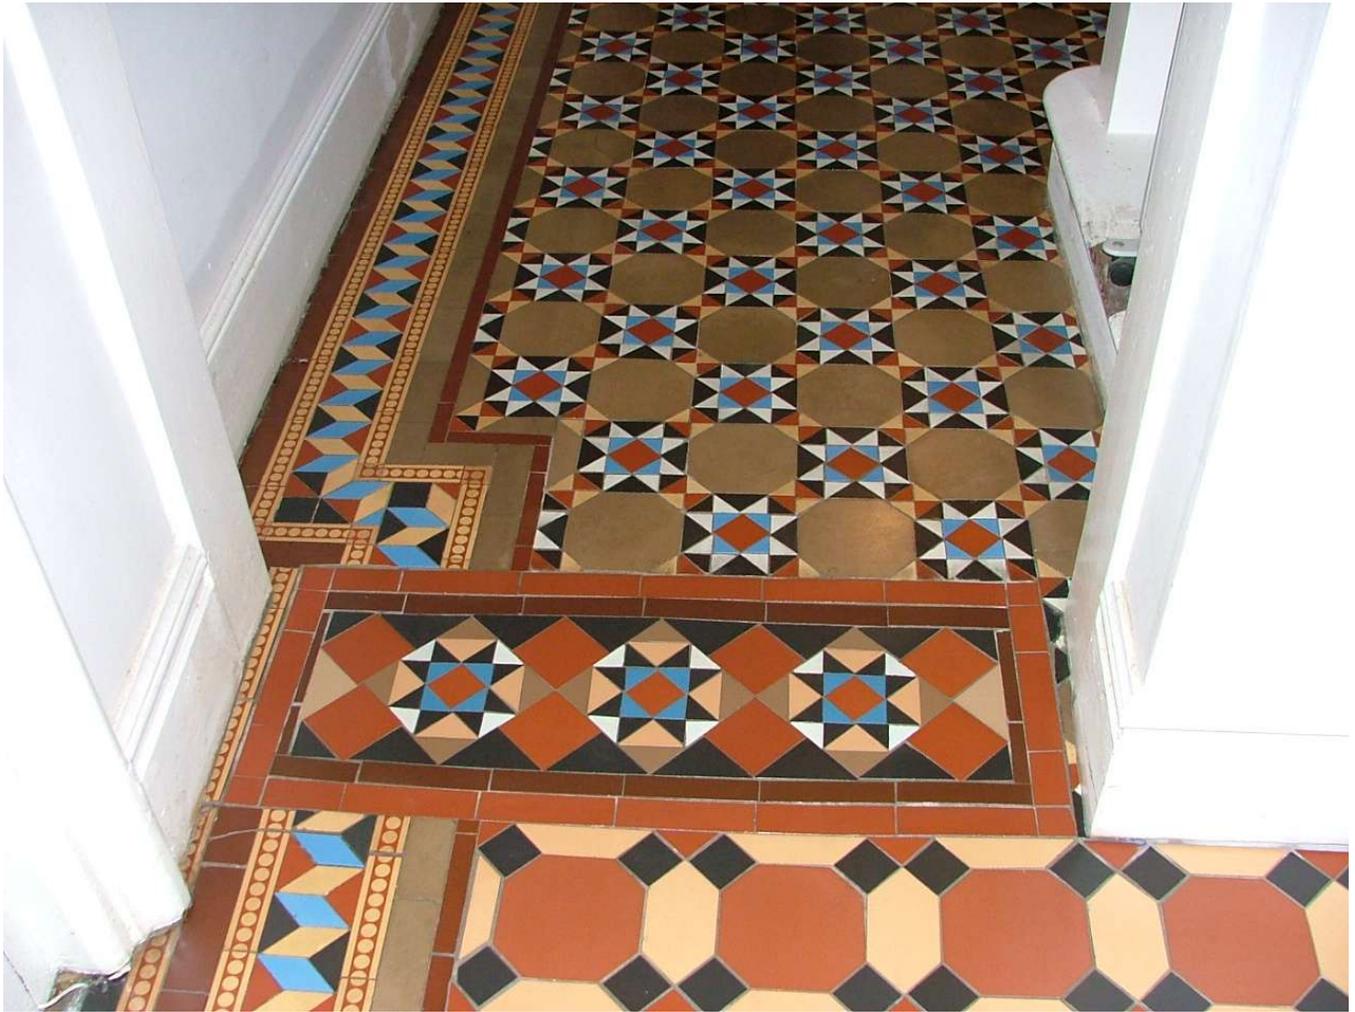
Restored section showing bridge between the new porch tiles and the original floor.

The above bridging section is a device I often use when confronted with an aesthetic & symmetry problem of joining two sections of a floor which are not square to each other or because some radical re-designing has had to take place to produce a workable design and keep the quality of the original floor yet perhaps have combined a new section which won't line up through to an original floor.

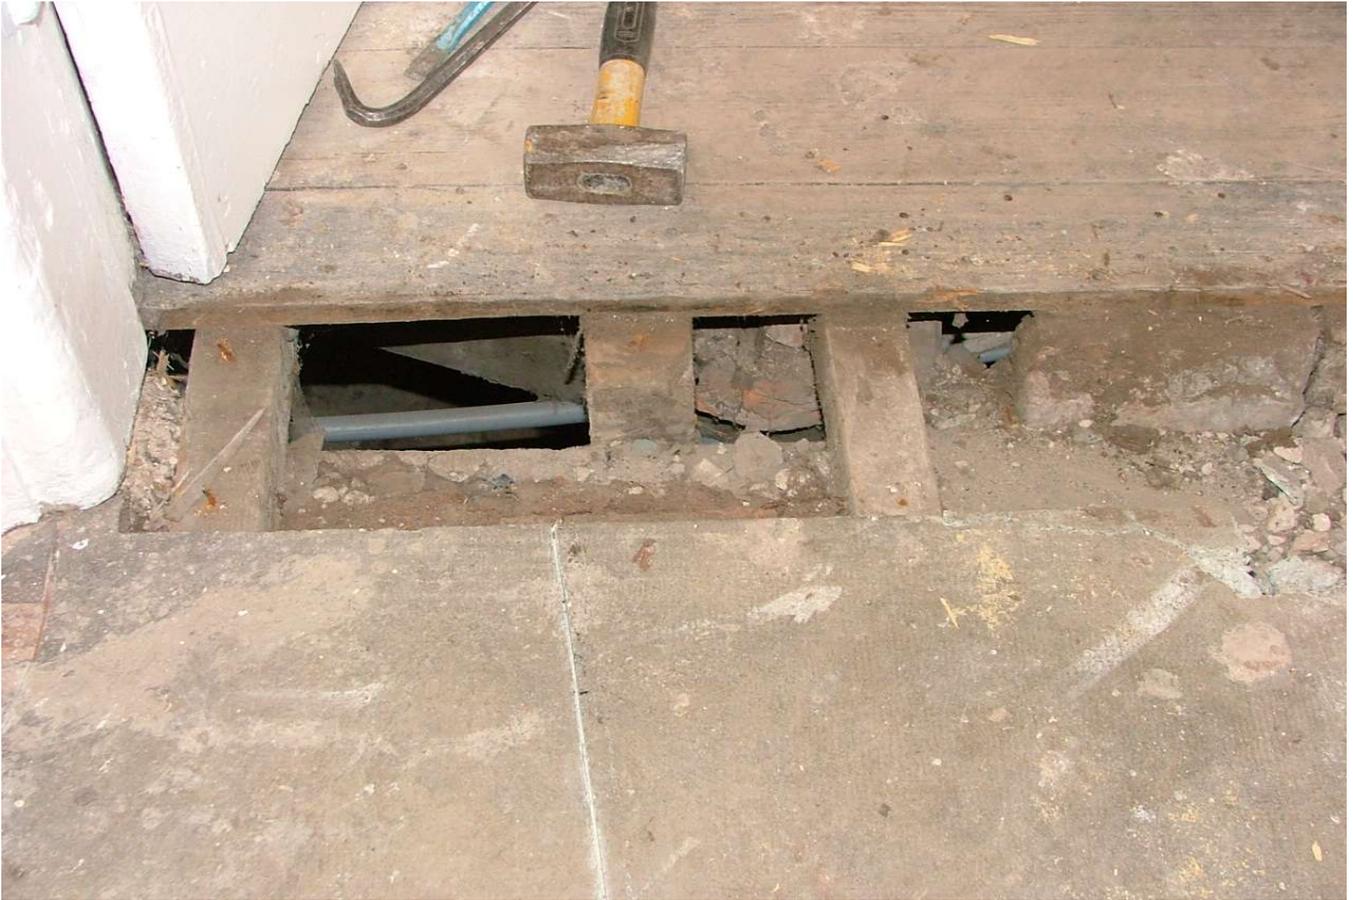
Wooden planking lifted showing space under the floor board's kitchen door section.

This threshold had lost its encaustic tile threshold at some point and then just had a rough plank nailed down to cover the exposed wooden joists & noggins. After lifting the wooden plank, the square section of concrete was cut around again with Exakt saws to prevent the percussive action of the hammers & chisel being transmitted to tiles that are firm and that I wanted to keep intact.

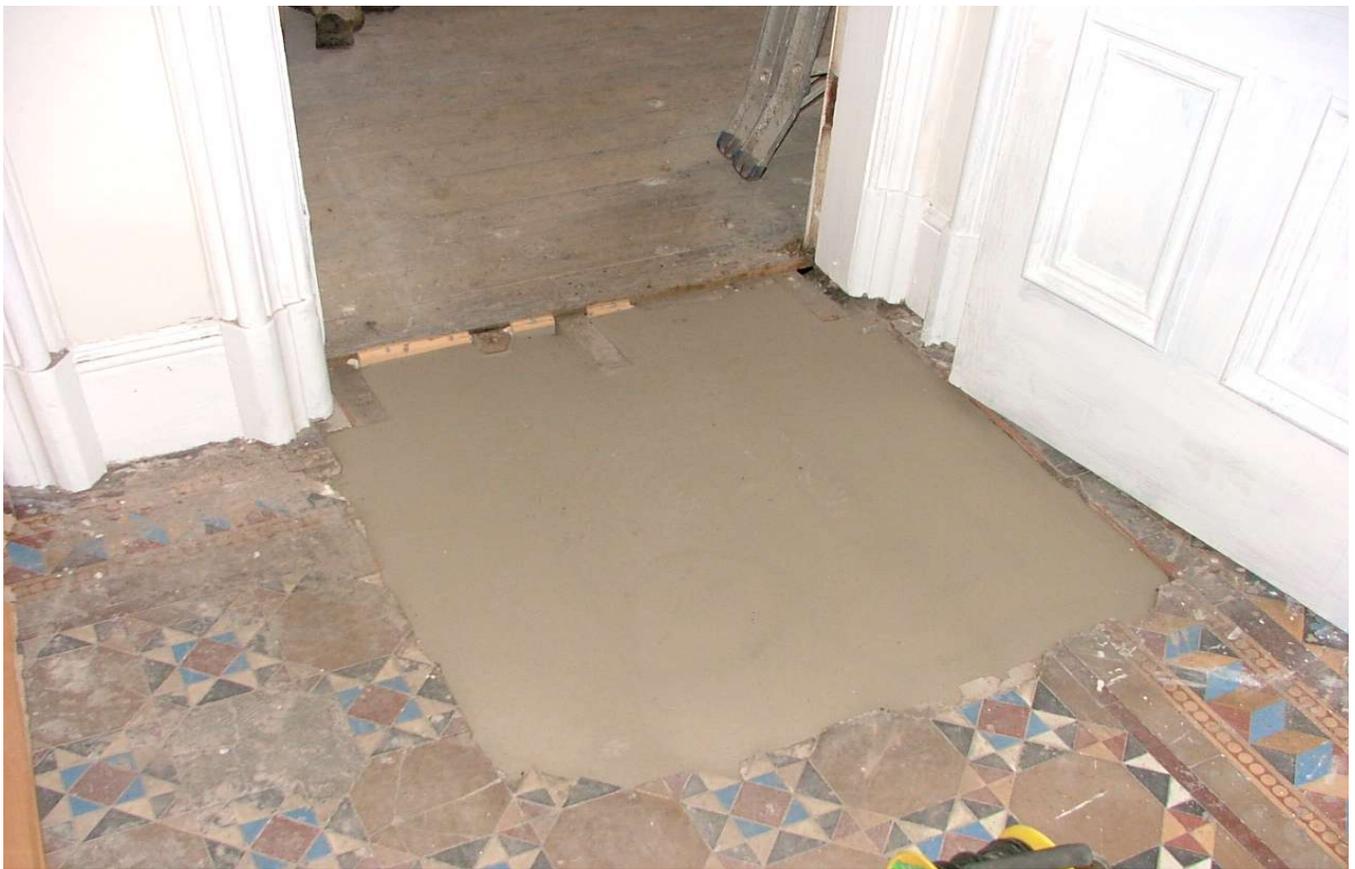
Kitchen door screeded at threshold & area that had been filled with concrete.

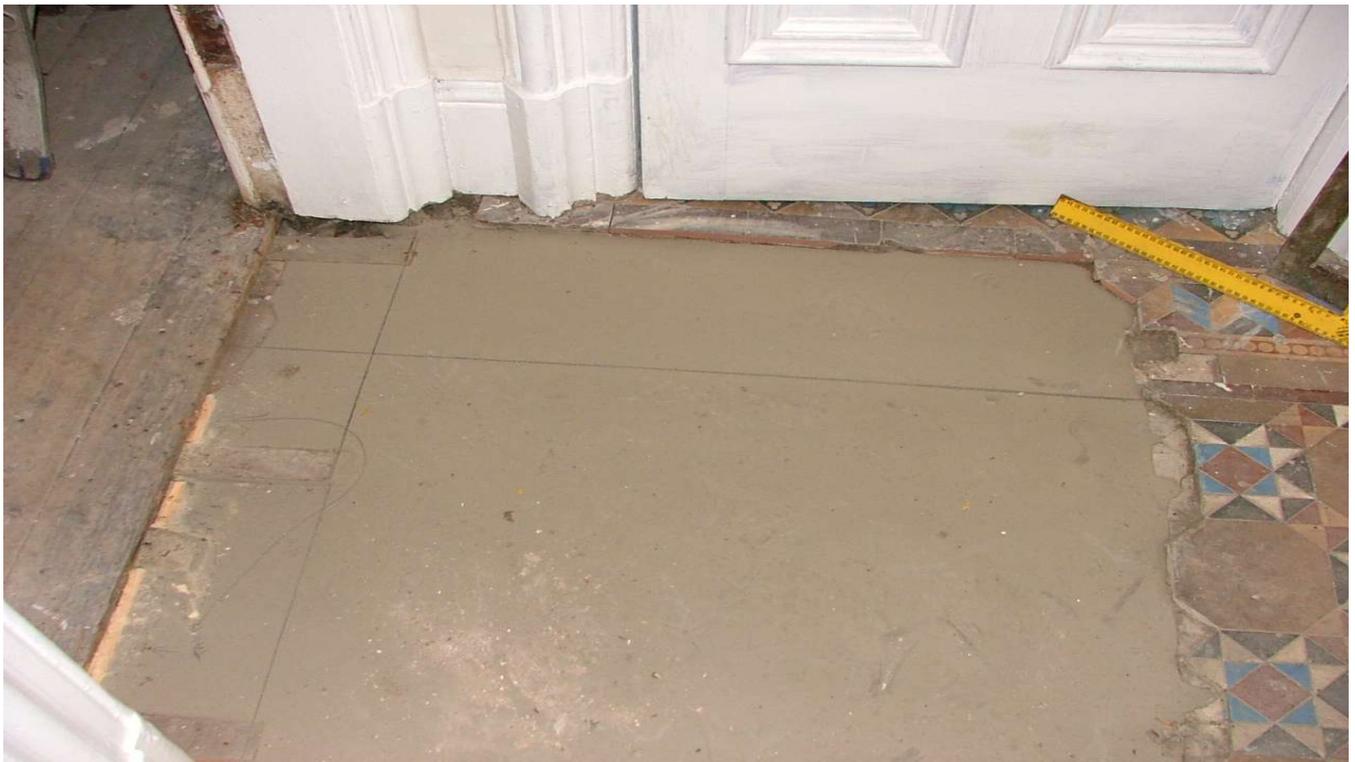
Same area marked to align border & threshold tiles.

This area is marked up for the above tiles which will be fitted prior to tiling the missing field tiles.

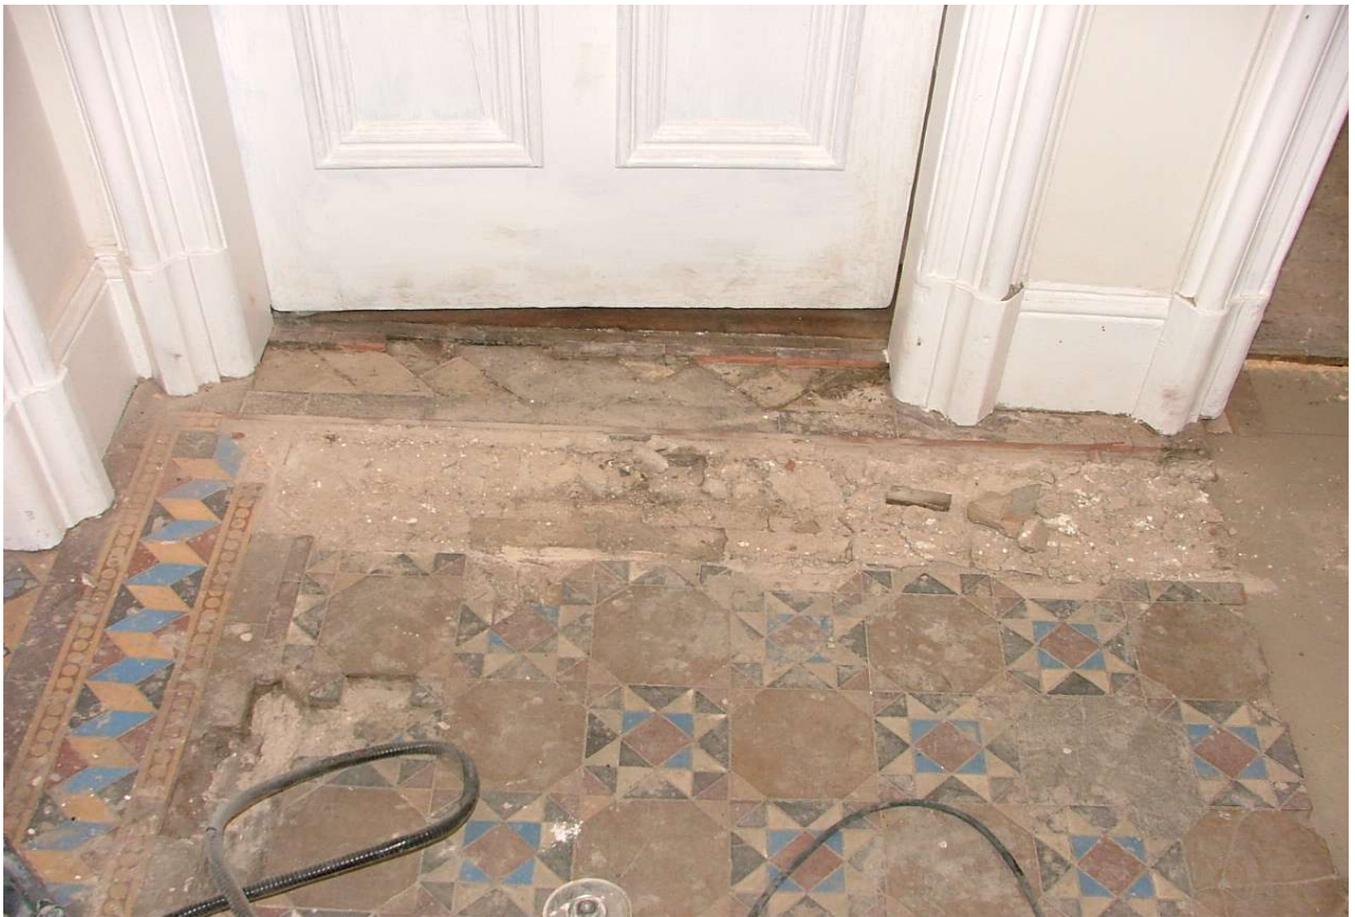
Section of in-fill being removed in front of dining room.

As can be seen here this section of infill links with the square section in front of the kitchen door.

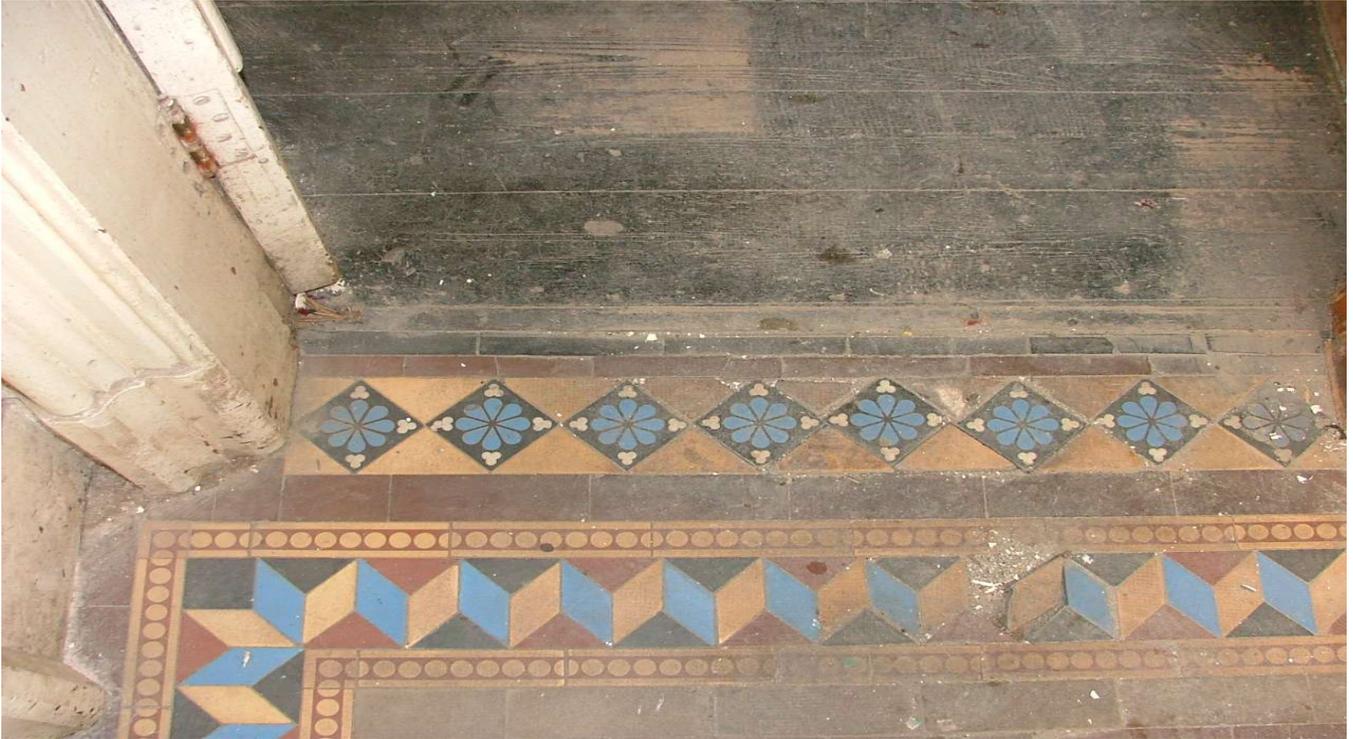
Dining room threshold with encaustics which are lifted to be spaced into the kitchen threshold.

Because of the amount of damage and the fact the kitchen thresholds tiles were missing I decided to use the remaining encaustic tiles and split them equally between the two thresholds = dining & kitchen thresholds I put black tiles in place for the missing encaustics, the clients declined to have new encaustics made as the cost for one mould and subsequent new tiles is costly. However the revised format blends well and does not look out of place.

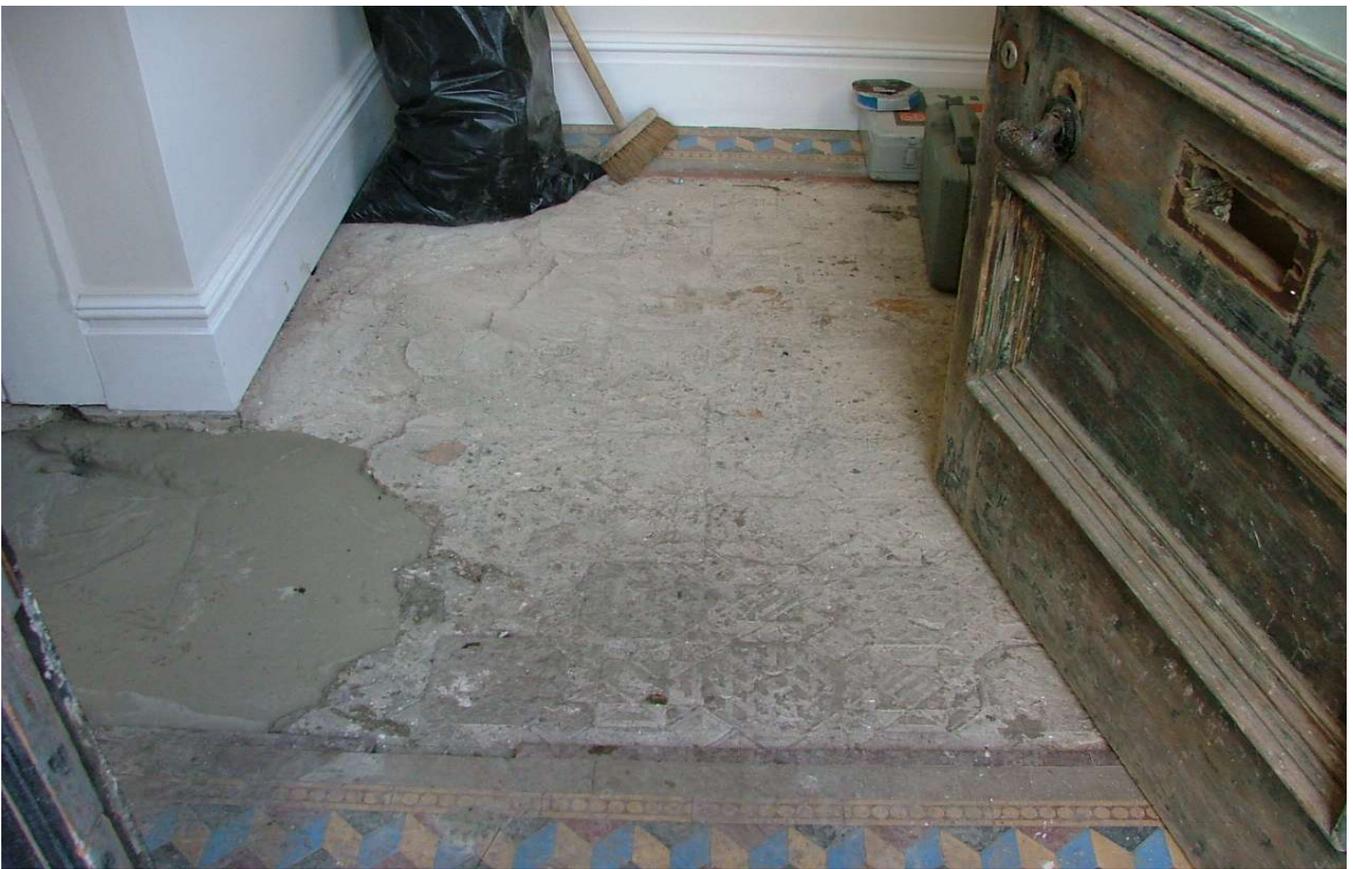
Porch tiles lifted to be used in main floor.

The existing porch tiles were lifted to be used to restore the main floor, the porch border tiles were retained to give continuity across the two areas of floor, a new tiled floor was fitted using tiles bought from Craven Dunnill at Jackfield these tiles are made to match authentically the original Victorian tiles = square edged imperial sized tiles.
