Belfast Harbour Office Grade A Listed Building Circa 1850 Extended 1895.

Contract to restore the fine Victorian Mosaic floors in marble on the upper floors & the un-glazed dust-pressed mosaic tile lower floors.

Harbour Office, Port of Belfast - Repairs and Cleaning of Mosaic Floors

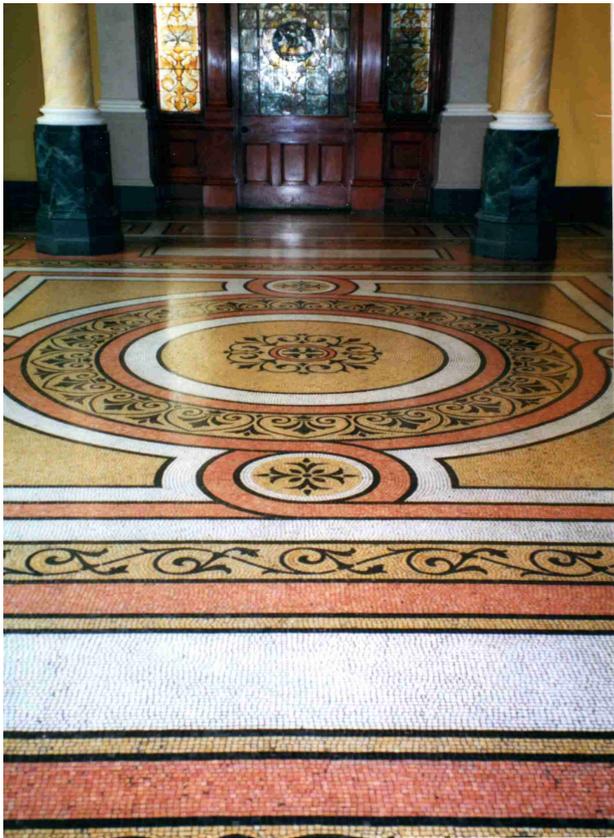
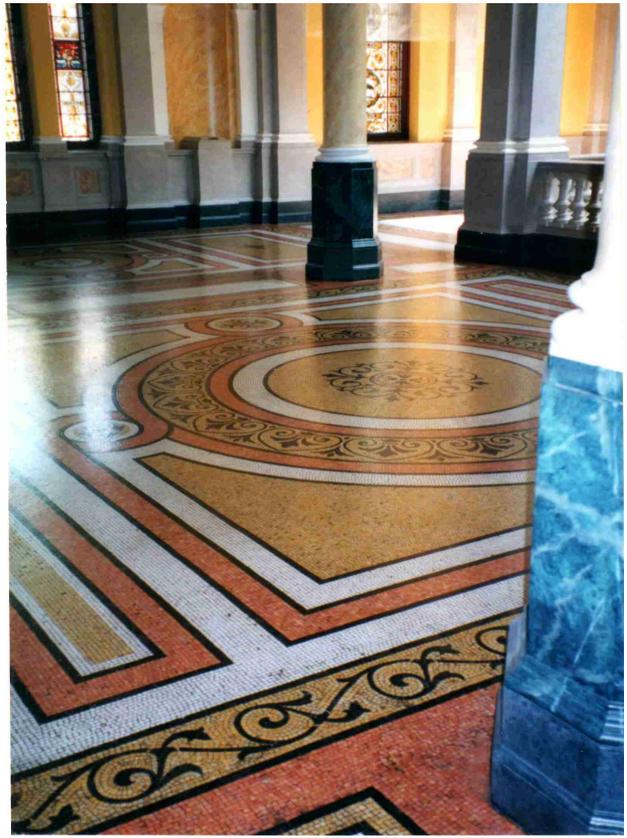
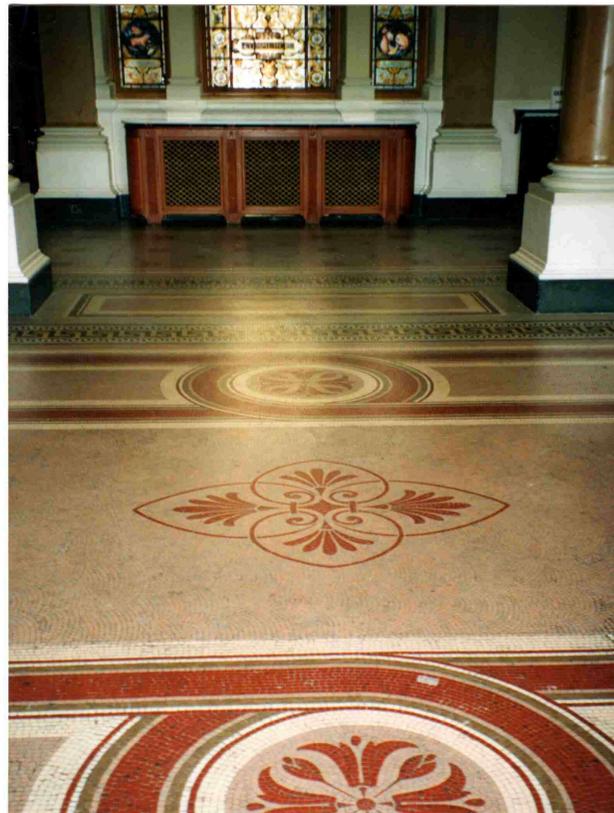
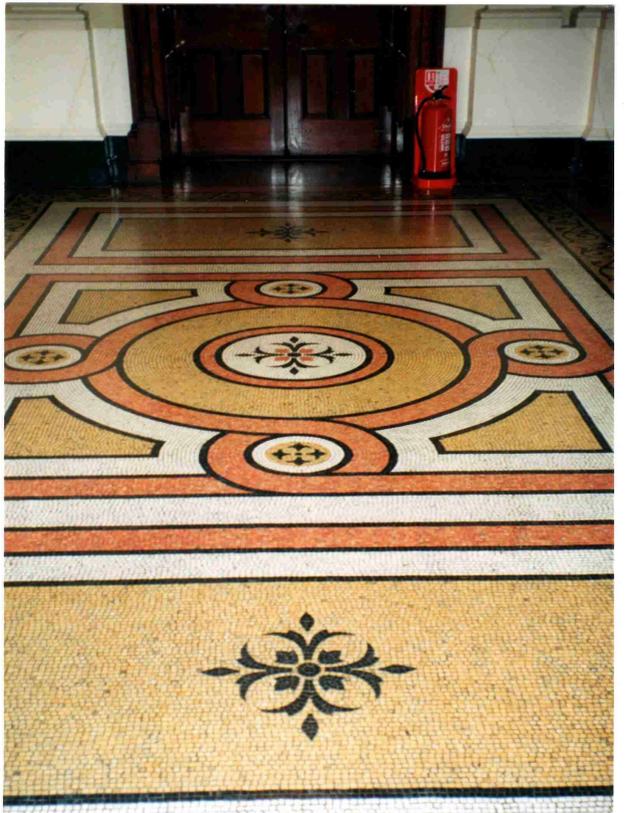
P3.

Pictures of the finished contract.

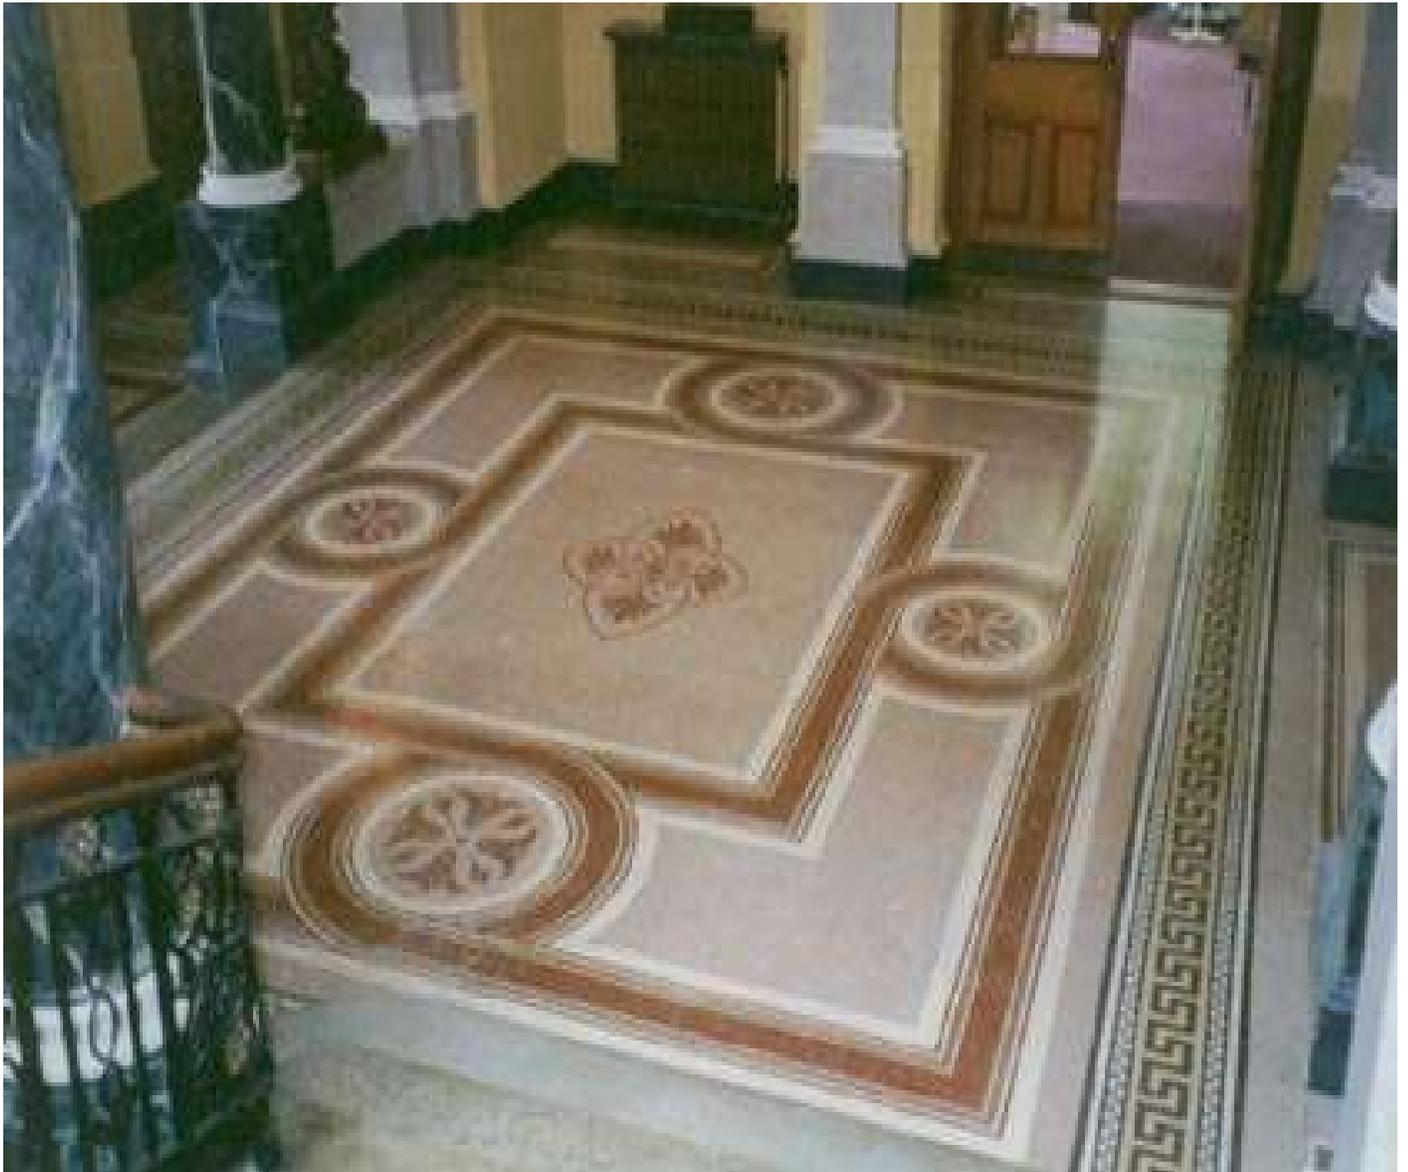
P4.

View from the stairs of restored Victorian mosaic tiled floor.
