Dairy Cottage at Haigh Hall Wigan, Grade 2 Listed building Total restoration of a Victorian Encaustic & Geometric tiled floor.

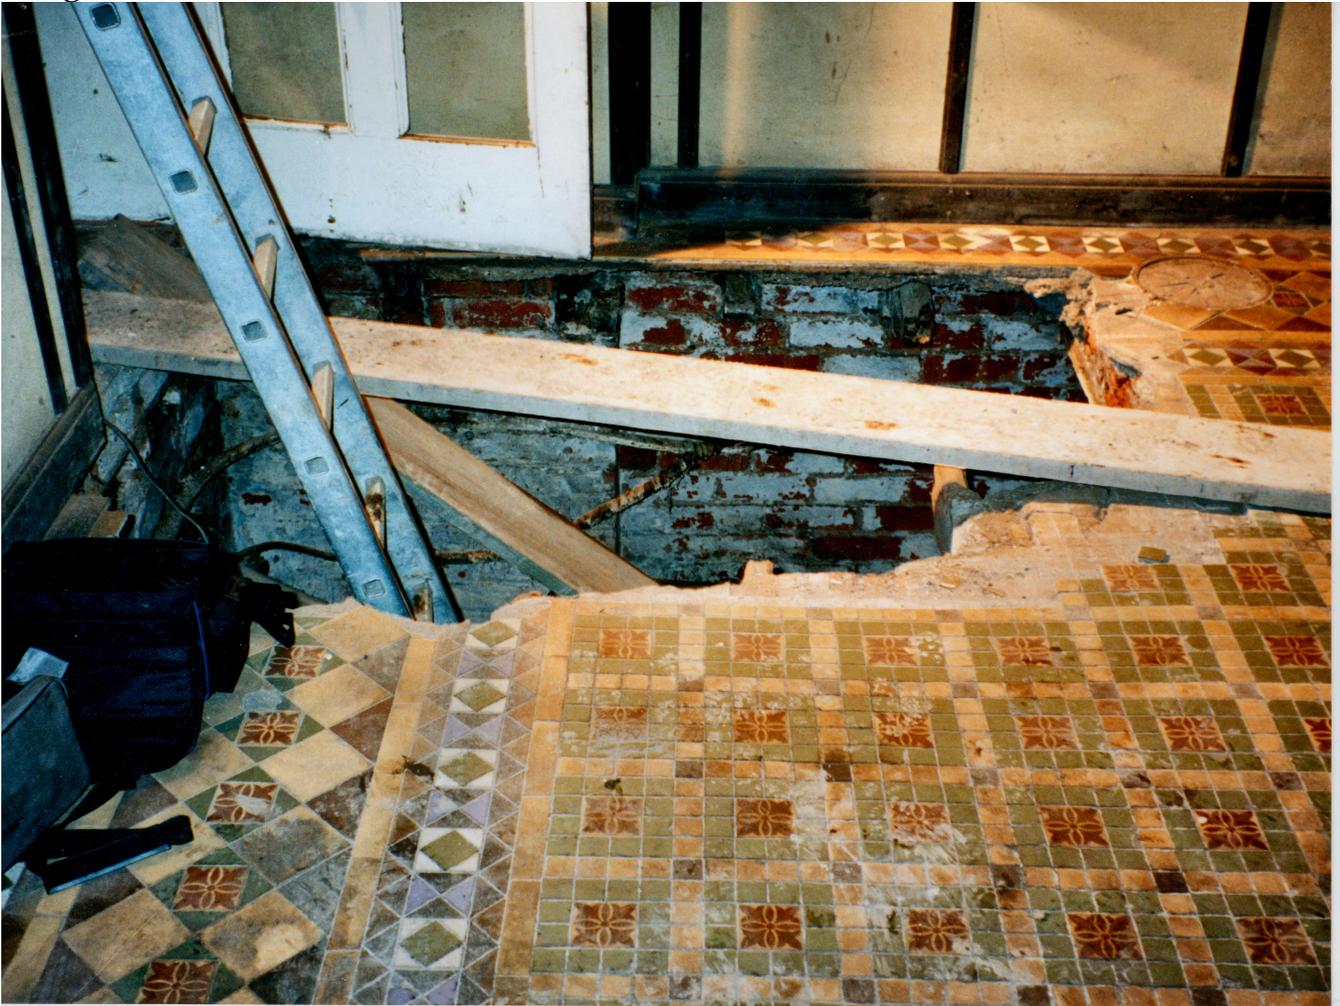
Over the last 39 years I have had to lift or recover whole tiled floors only 7 times, the contract here at Dairy Cottage meant that the whole tiled floor had to be lifted a huge amount of it had already fallen into the cellar below and although we recovered more from the floor, we still had to root amongst the debris to get the dropped floor tiles. The rest were recovered using large boards to displace our weight and that took a considerable amount of time.

Dairy Cottage showing substantial damage.

Top right hand corner of the picture shows a circular plate, there were a number of these fitted into the floor, we never found what they were for or the reason behind them, and they were badly corroded so they didn't get re-fitted into the completed floor.

To restore this particular floor the original floor was removed and new floor support system was fitted = a concrete beam & block floor.

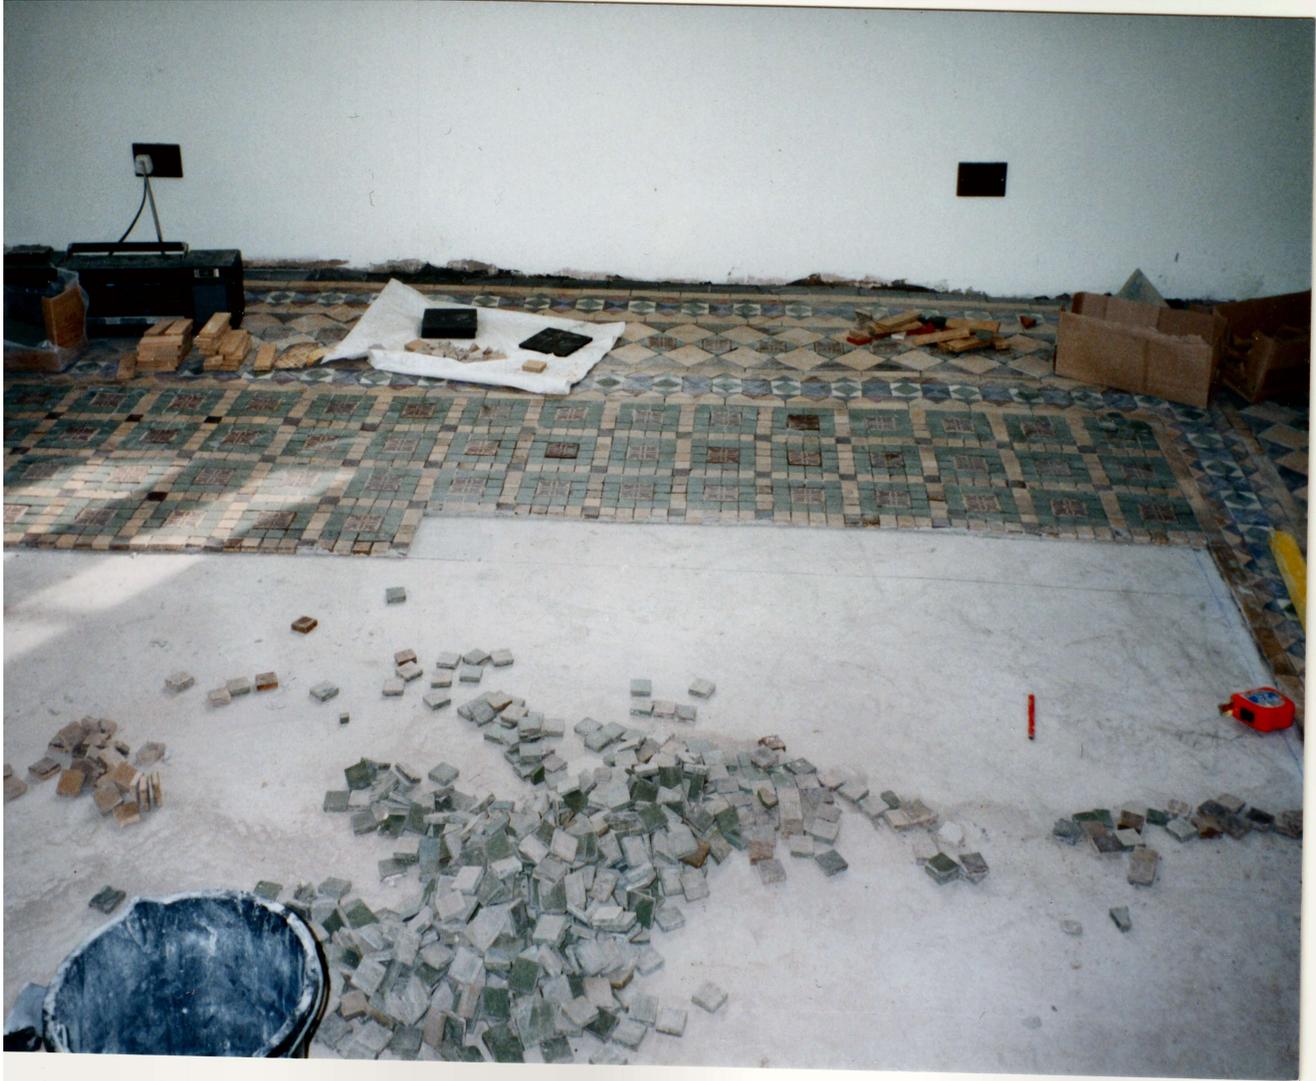
Floor installation underway.

Because of the size of the huge border setting out also took some time and we had to re-introduce a slight kick in the border which was present in the original floor!

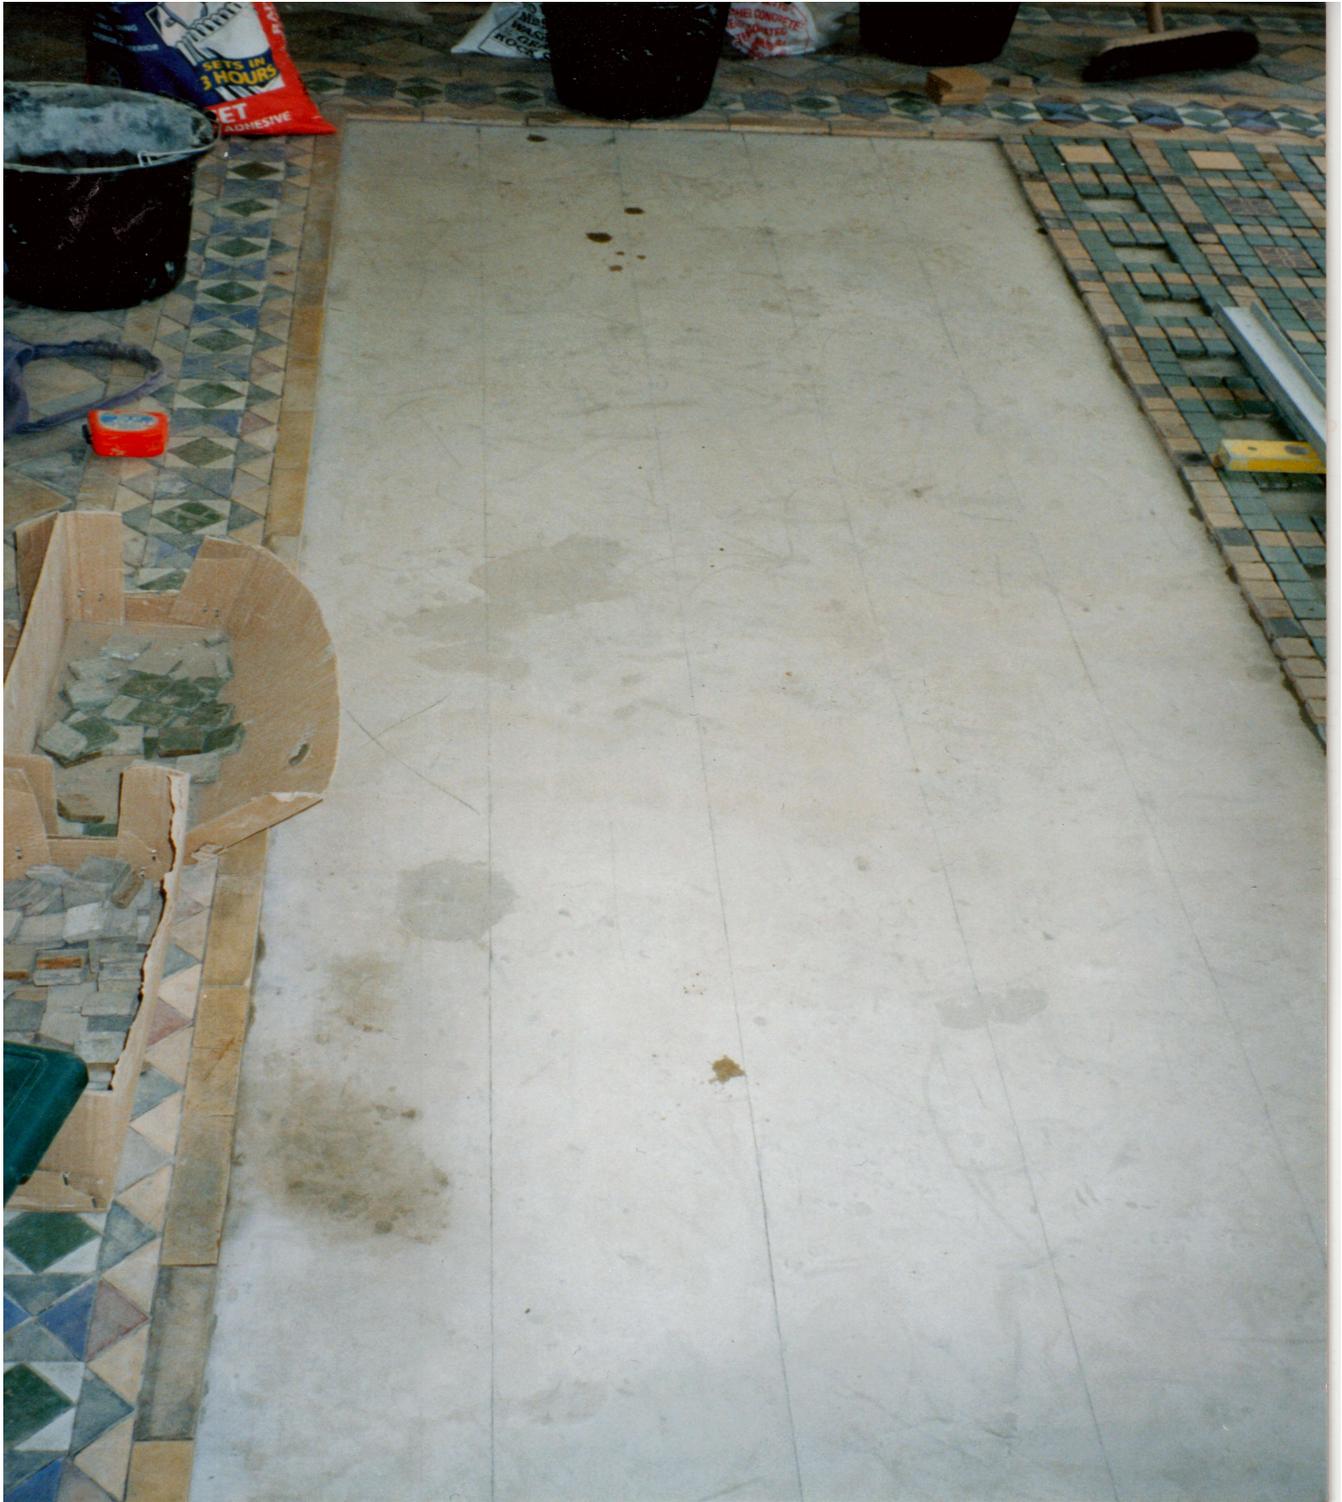
Dairy Cottage floor nearing completion.

Although only a few of the original tiles had broken and we had removed 6 discs of metal out of this floor we ended up with some tiles over! We didn't install the floor until the walls had been plastered I assume it had been filled out a couple of inches more.

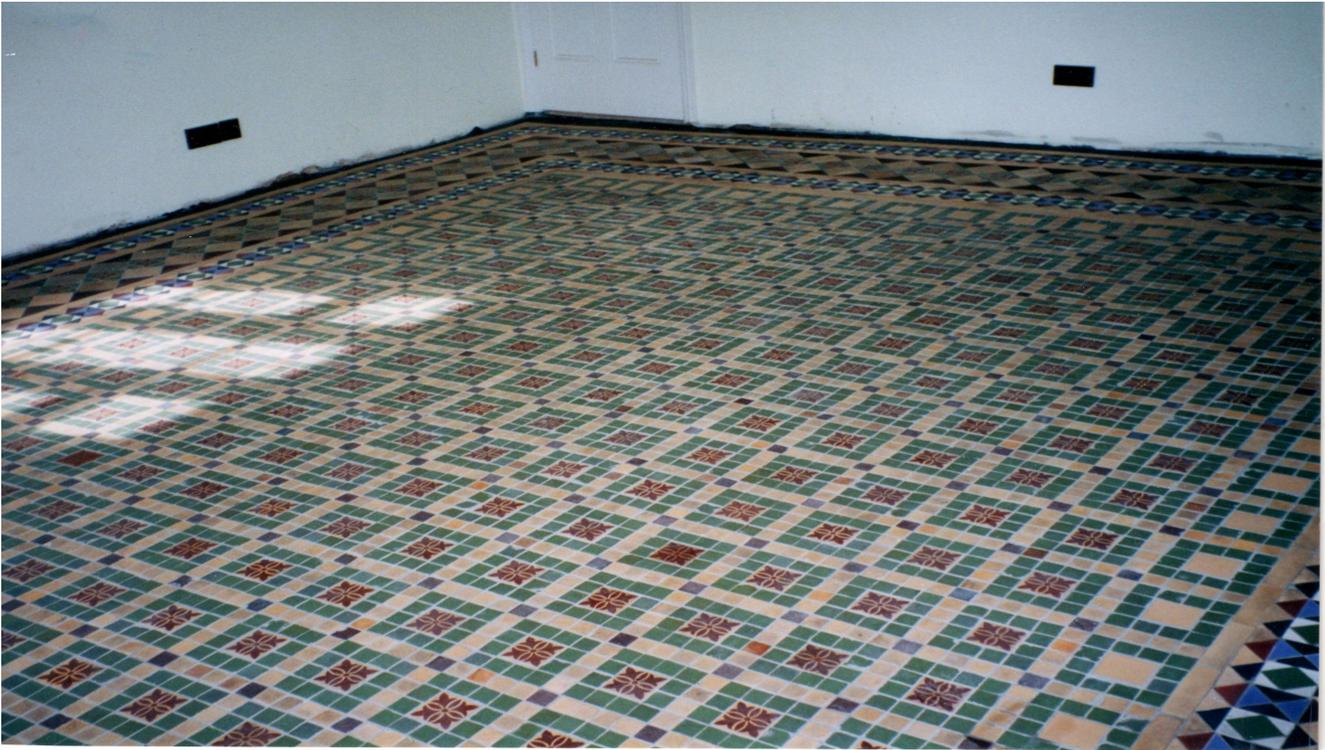
Completed floor at Dairy Cottage Haigh Hall Grade 2 listed building.

The floor was fixed with BAL flex adhesive and grouted with a flexible grout also by BAL.

After a few days to allow the floor to set properly we cleaned the tiles 6 times with at first a mild alkaline cleaner then a natural acidic cleaner = Seville orange from Selden research, after that it was cleaned twice with a PH neutral cleaner after which just clean hot water. We used a Numatic 200 rpm Scrubbing machine.

Sealing took place 2 days later and we coated the floor with 4 coats of British Nova sealer.
