Edinburgh Late Victorian Stone built mansion, Encaustic & Geometric Restoration.

The client Gavin & Lynne Neilson had a hell of a job restoring this Edinburgh townhouse a Grade B listed building the floor had been covered in cement based levelling screed and during renovation work some brick acid had been spilt which etched through showing the tiled floor underneath.

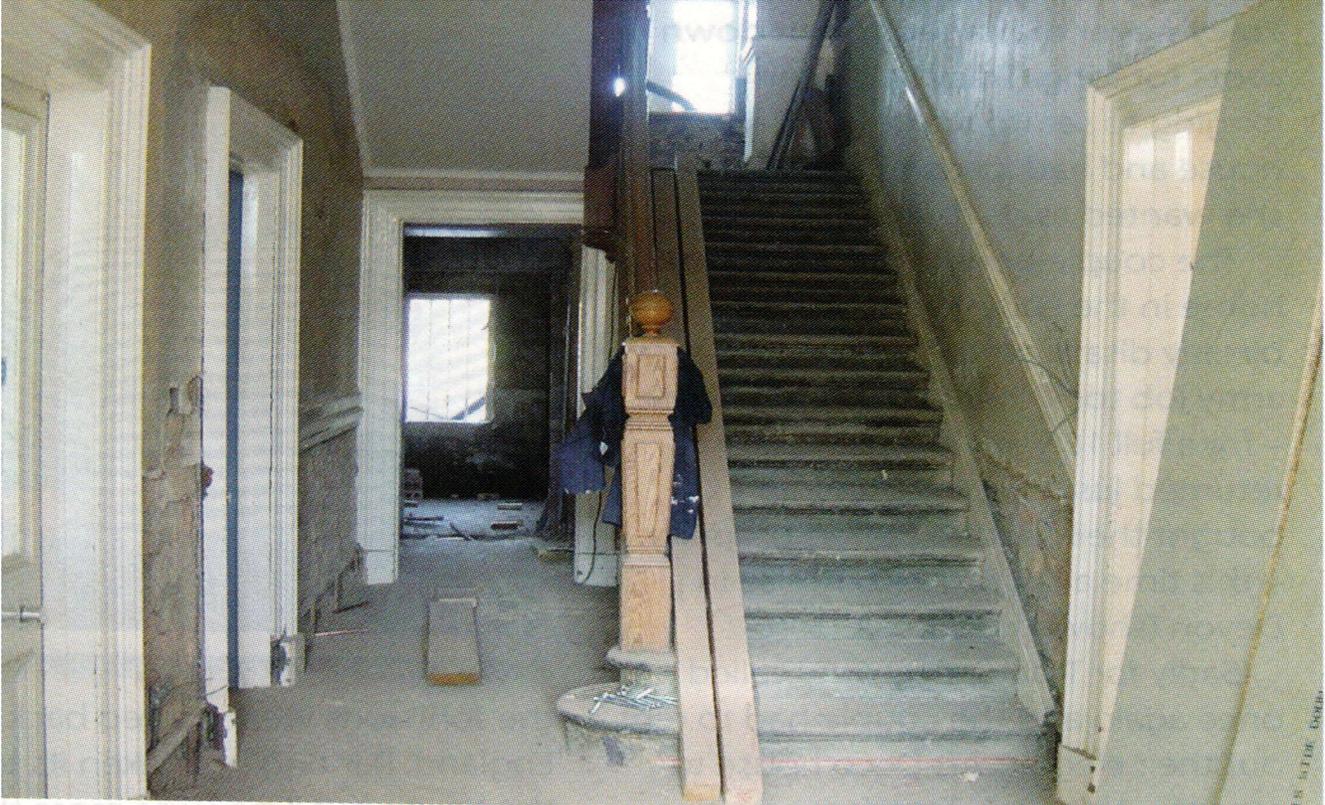
My guess the floor had been covered with a levelling compound and then carpeted.

Floor showing grey levelling compound.

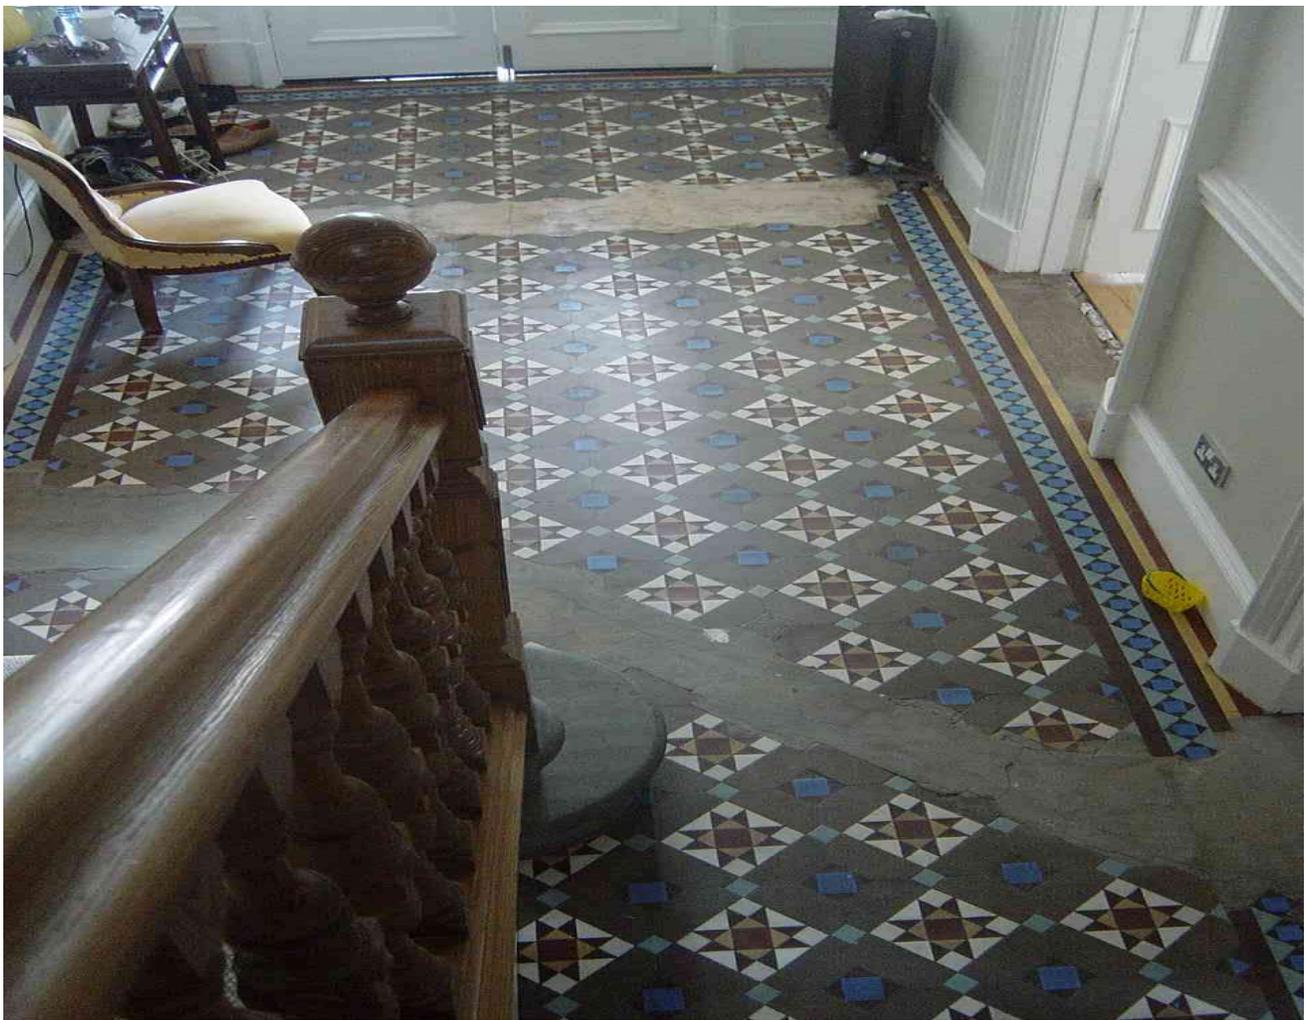
GN floor showing trench infill & missing thresholds.

The first important step is the removal of the concrete in-fill and as is often the case this is a laborious process as taking out the in-fill can cause other sections of the tiles to jar loose.

However we are able to limit this problem by the use of Exakt saws (a Scottish invention) we use these precise cutting saws with a diamond blade to remove damaged tiles and to cut a perimeter line around the trenched areas.

After the in-fill had been removed a glass fibre rich screed was used to fill to fill the trenches back up to a level that was low enough to use a latex self-leveller to provide the final base for the new & re-claimed tiles to be fitted, the final screed finished just below the bed of the in-situ original tiles this is to allow for a bed of flexible adhesive to fix the replacement tiles.

New patterns were cut for the missing threshold tiles and after all the missing or loose tiles were fixed replaced the whole floor was cleaned with a low 200 rpm scrubbing machine fitted with a black pad, the floor was cleaned 6 times with various cleaning fluids.

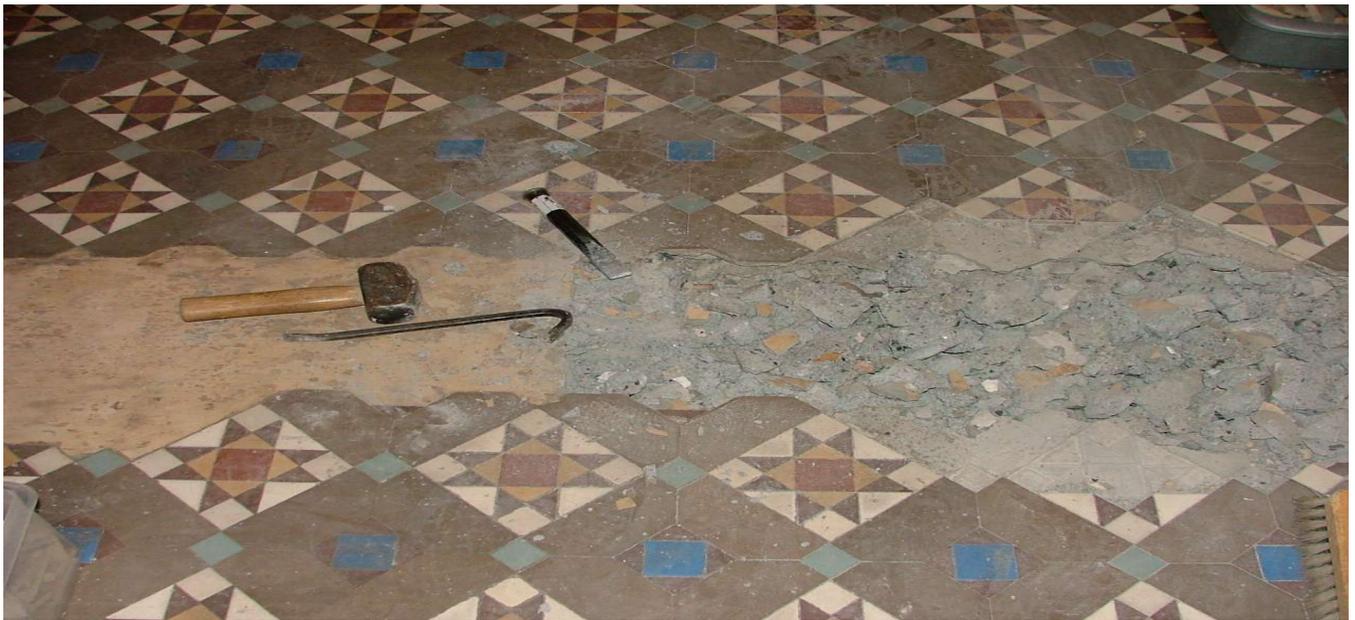
Close up of the damaged caused by the in-fill trench.
P3.

this is typical damage sustained by Victorian tiled floors all over the UK in the scramble to provide central heating from the 1960's onwards until people came to their senses then it was commonly accepted that these beautiful floor's would be sacrificed to facilitate runs of copper piping, possibly in some cases the plumber/gas-fitter may have had some conscience and fitted the pipes in a manner that didn't mean chopping the floor up! However we as a restoration co obviously do not see those floors.

This line cuts into the screed and prevents the percussion from the hammer & chisel causing any tiles to jump loose.

This particular infill was extremely hard and burnt two diamond blades out plus we had to cut in tandem as the concrete had been mixed with granite chippings (a common addition to the screeds in parts of Scotland) which meant the saws heated up quickly given the granite is only a 1.5 below diamond on the Mohs scale.

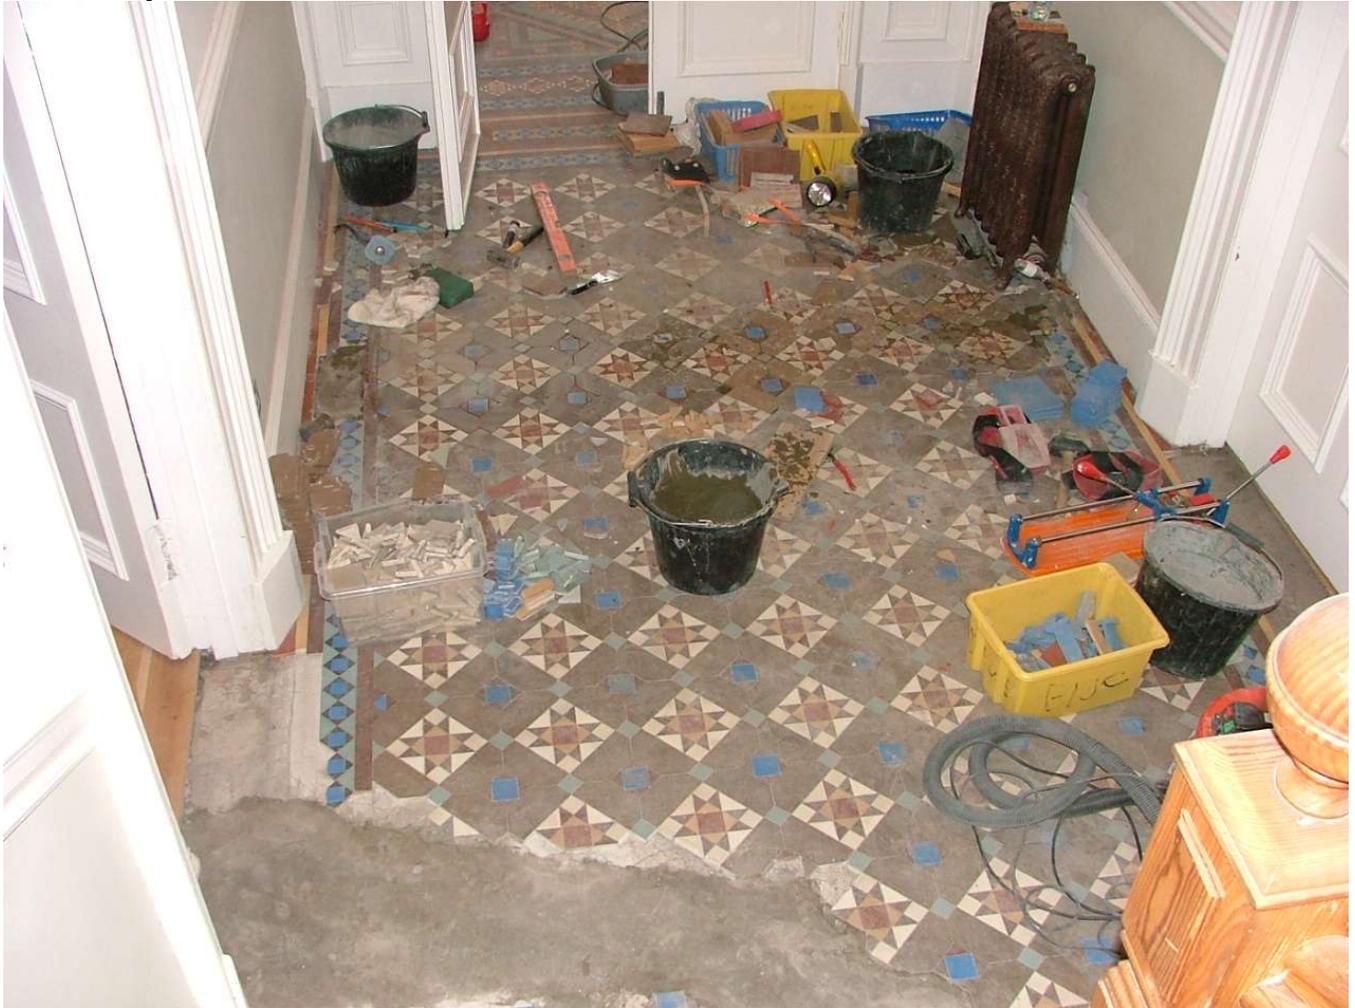
Showing the trench nearest the porch door re-tiled.

The replacement tiles came from our stock of collected tiles we also used new tiles obtained from Craven Dunnill the only manufacturer that produces square finish tiles suitable for tile restoration.

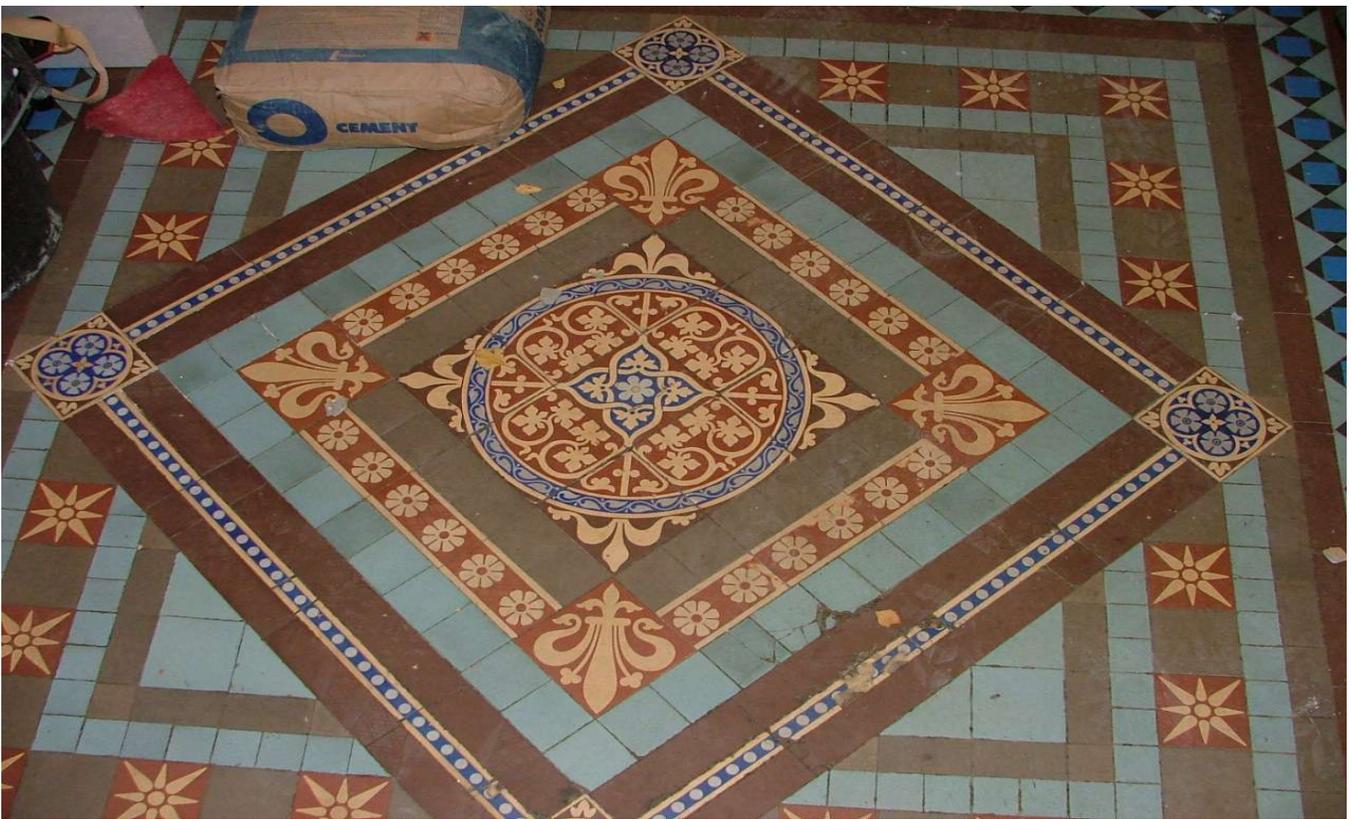
GN detailed encaustic porch floor prior to restoration.

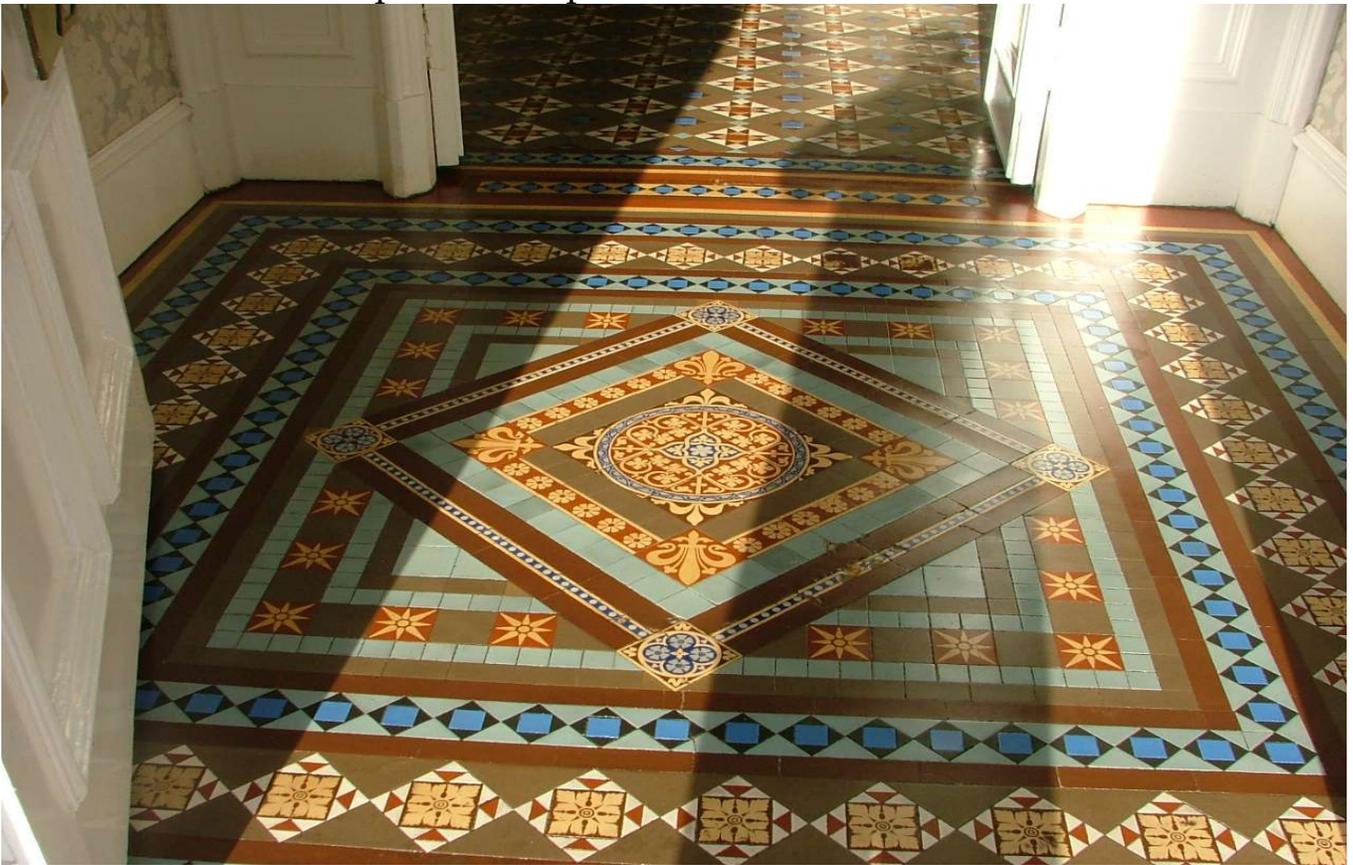
GN elaborate Victorian tiled porch floor restored.

It was then sealed two days later with a sealer from British Nova.

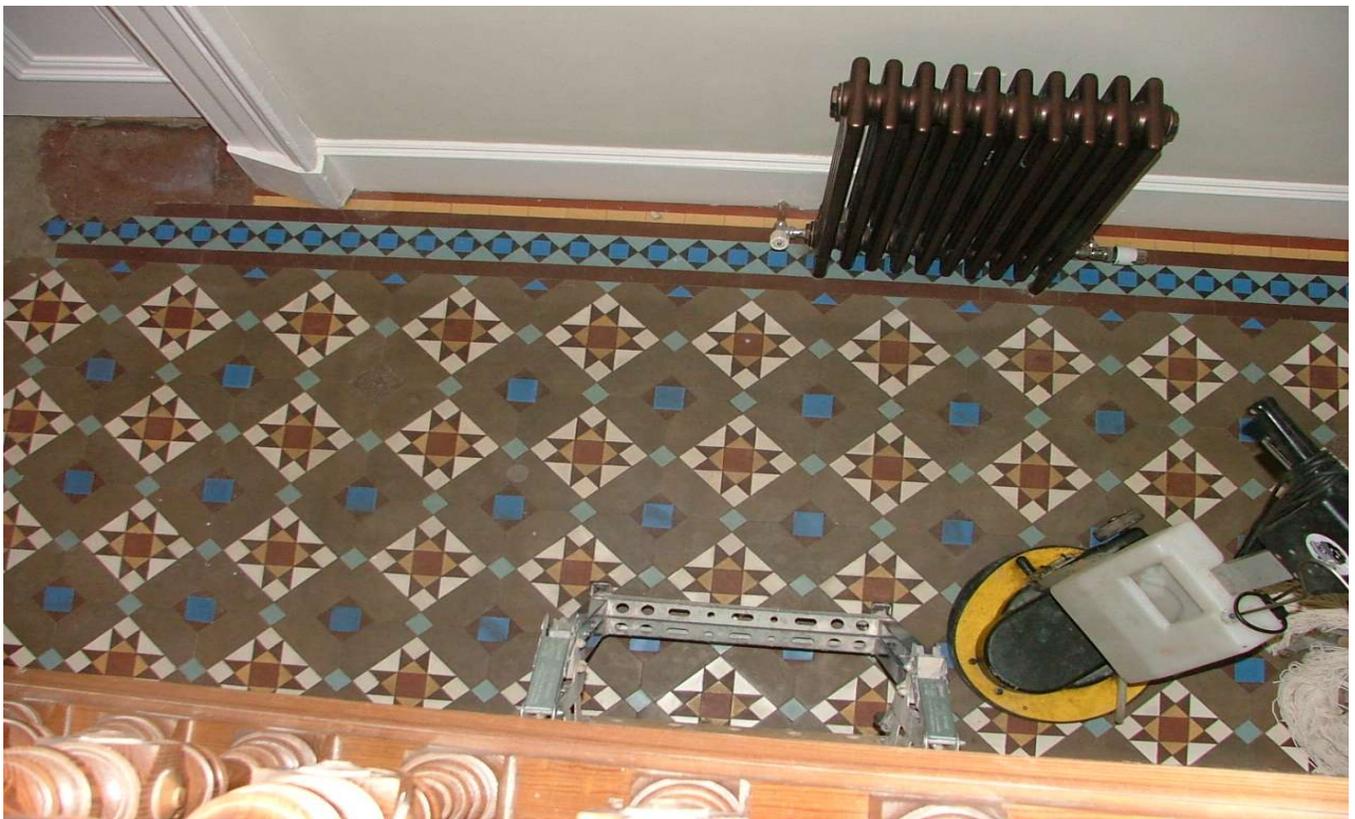
GN side of stairs before restoration.

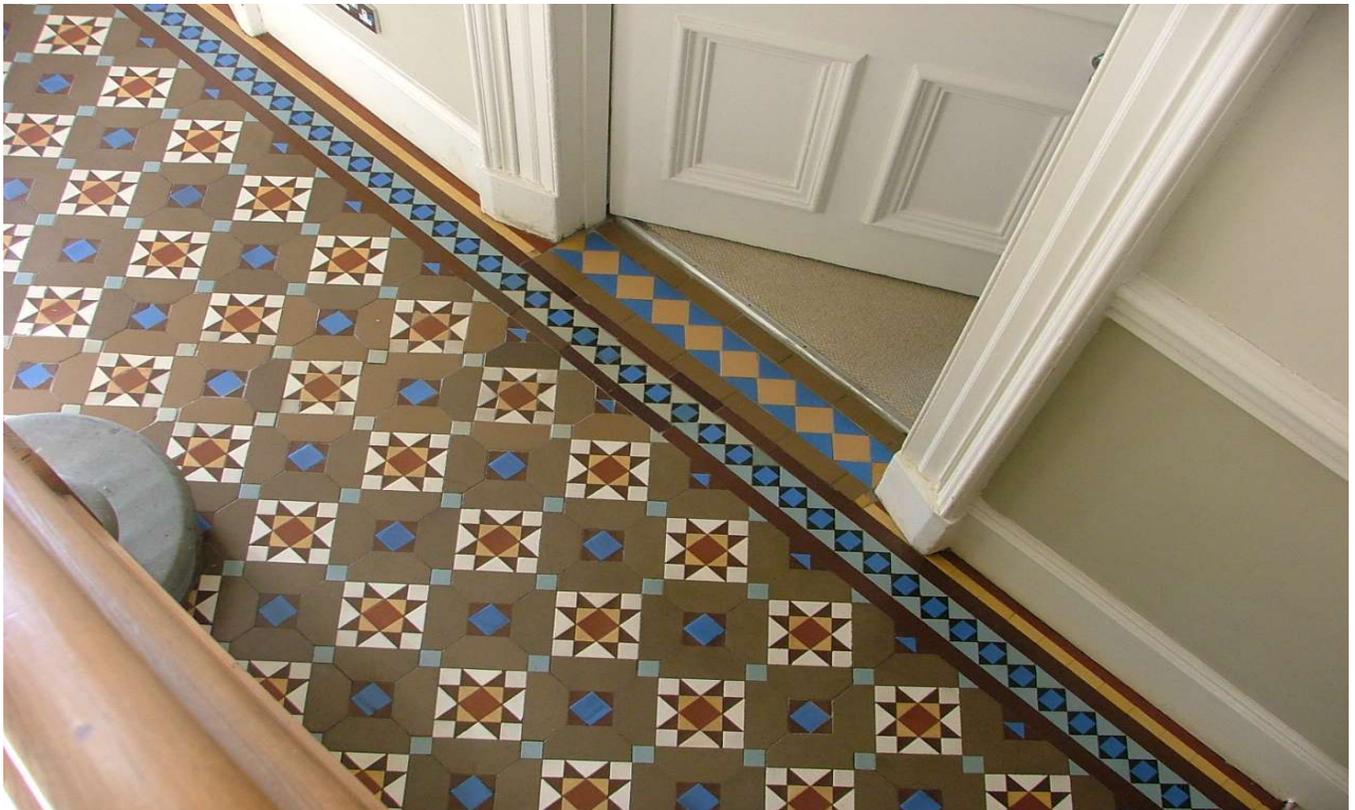
GN side of stairs restored.

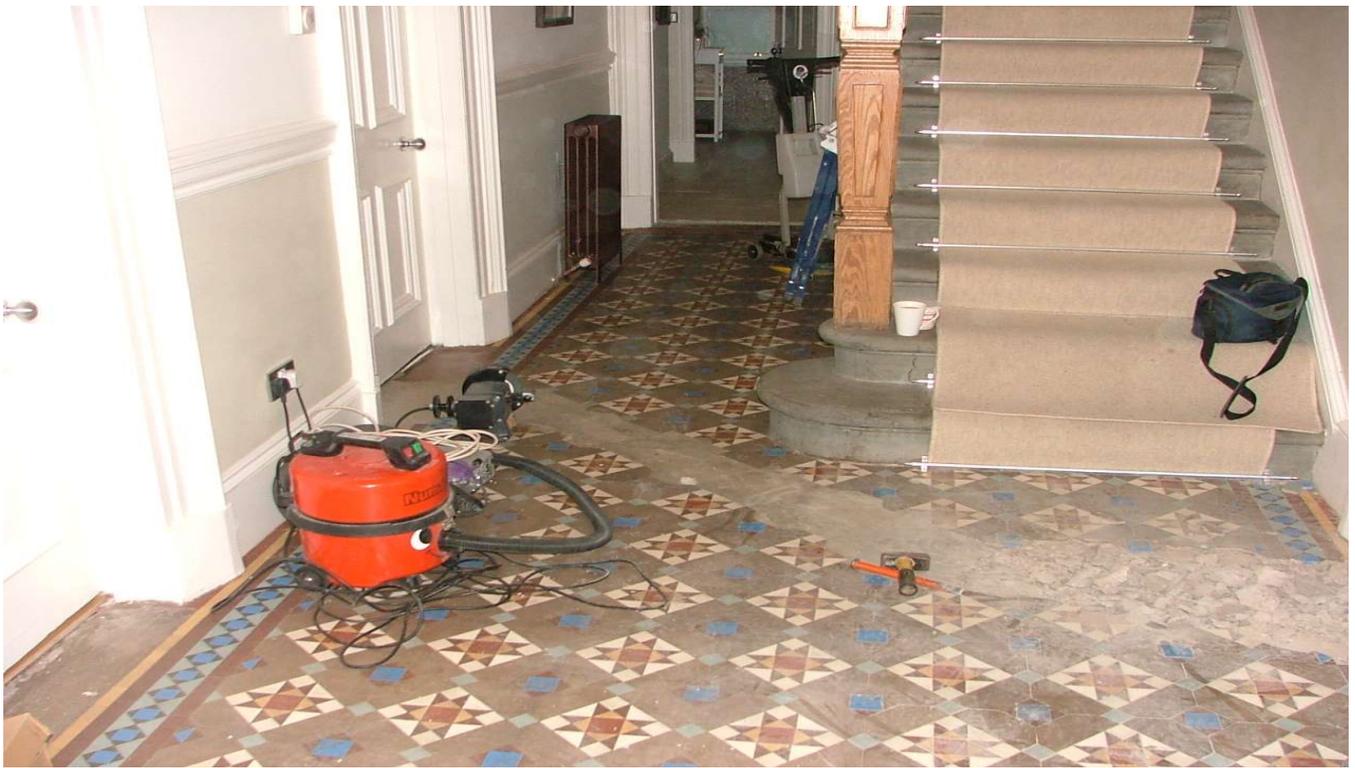
GN floor before restoration.

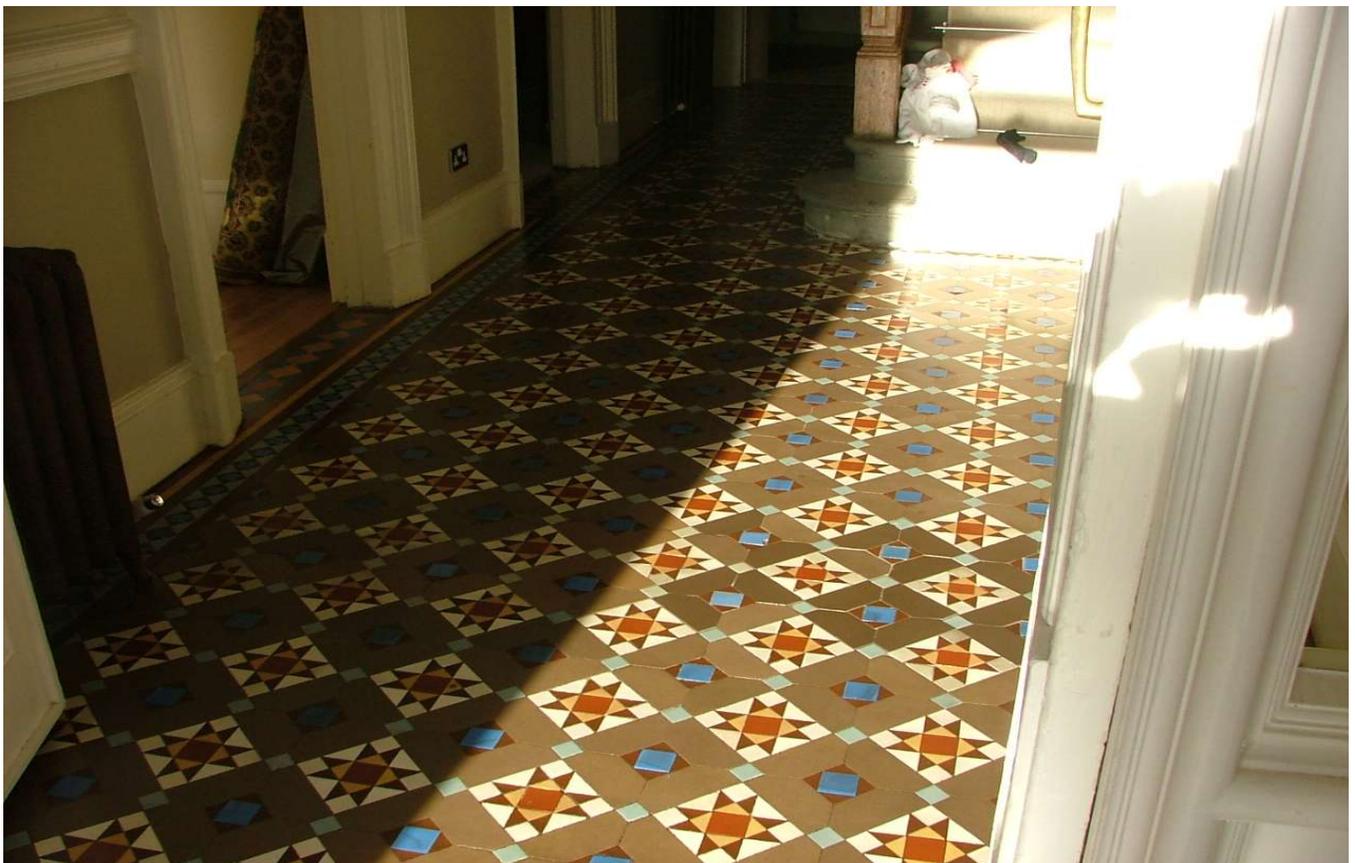
GN Floor restored.

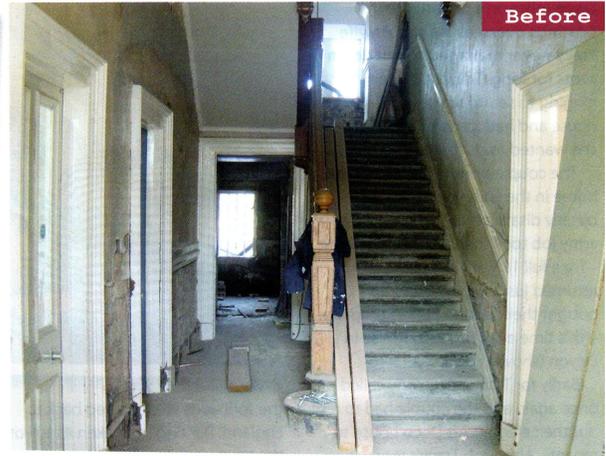
Before

It's a tale to turn many renovators green with envy – how a chance spill led to the discovery of a stunning Victorian mosaic floor, which lay hidden under a layer of concrete for years. 'Acid dropped onto the concrete floor while we were working in the hall and burnt right through the screed,' says Gavin. Through the hole the couple could just spy the tiled floor. They removed the screed – a painstaking job in itself – then discovered two concrete channels running through their lovely floor.

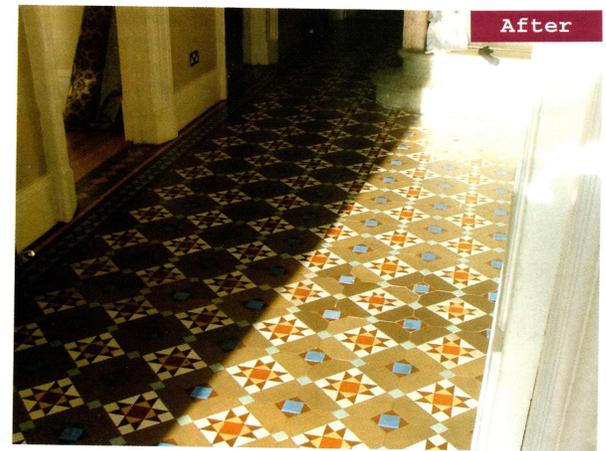
After

ABOVE Geometric tiles are usually unglazed, with straight-edged shapes, such as triangles and lozenges, in natural clay colours ranging from off-white through to red brown to a blue-black TOP The house still has one exciting question left: what other gems are hidden just waiting to be discovered?

Luckily, Steve Sinnott of Heritage Tiling was able to patch it up. 'He owns a huge amount of reclaimed tiles,' says Lynne, 'so he matched up as best he could from his stock and finished the rest with modern tiles.'
