Frodsham Contract. Unlisted.

A small Geometric floor damaged by heave due to a later addition of a stone built porch. Typically the porch did not sit upon a decent foundation and had sunk slightly over the years, the porch was added some decade or so after the main house had been built house was circa 1880, porch 1890's.

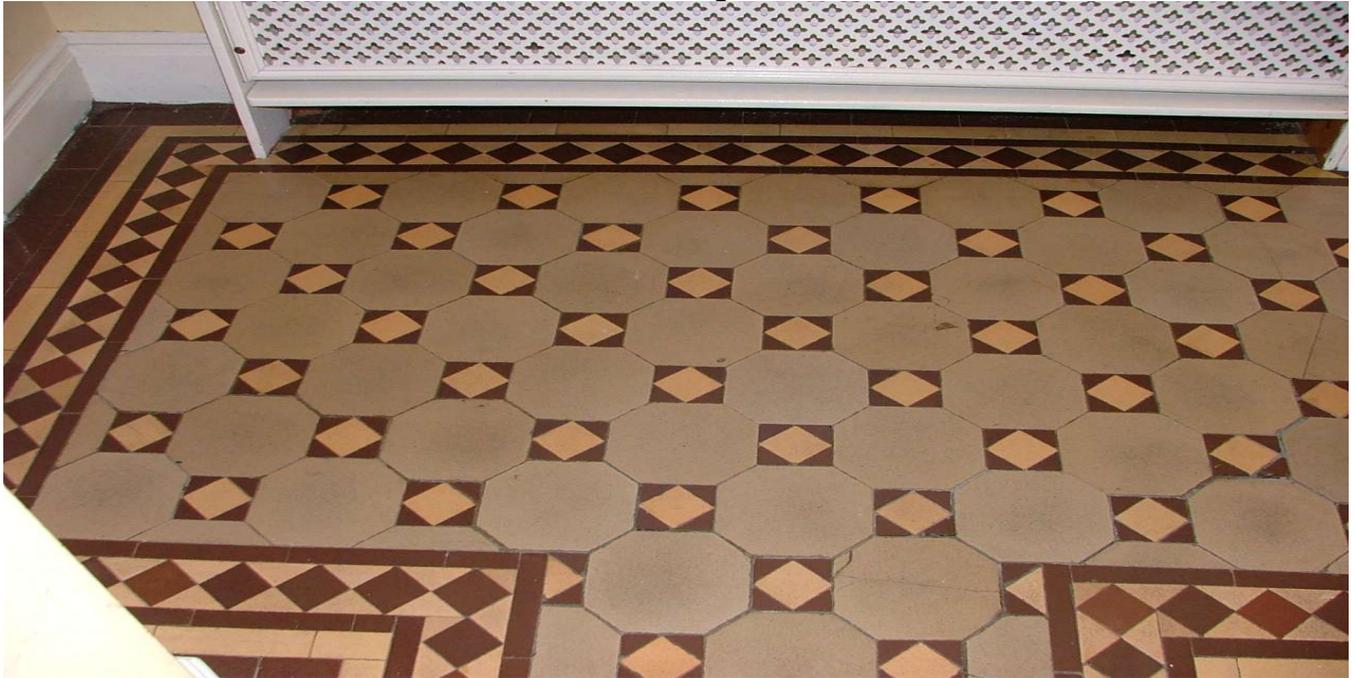
Tiles loose & cracked in this before restoration pic.

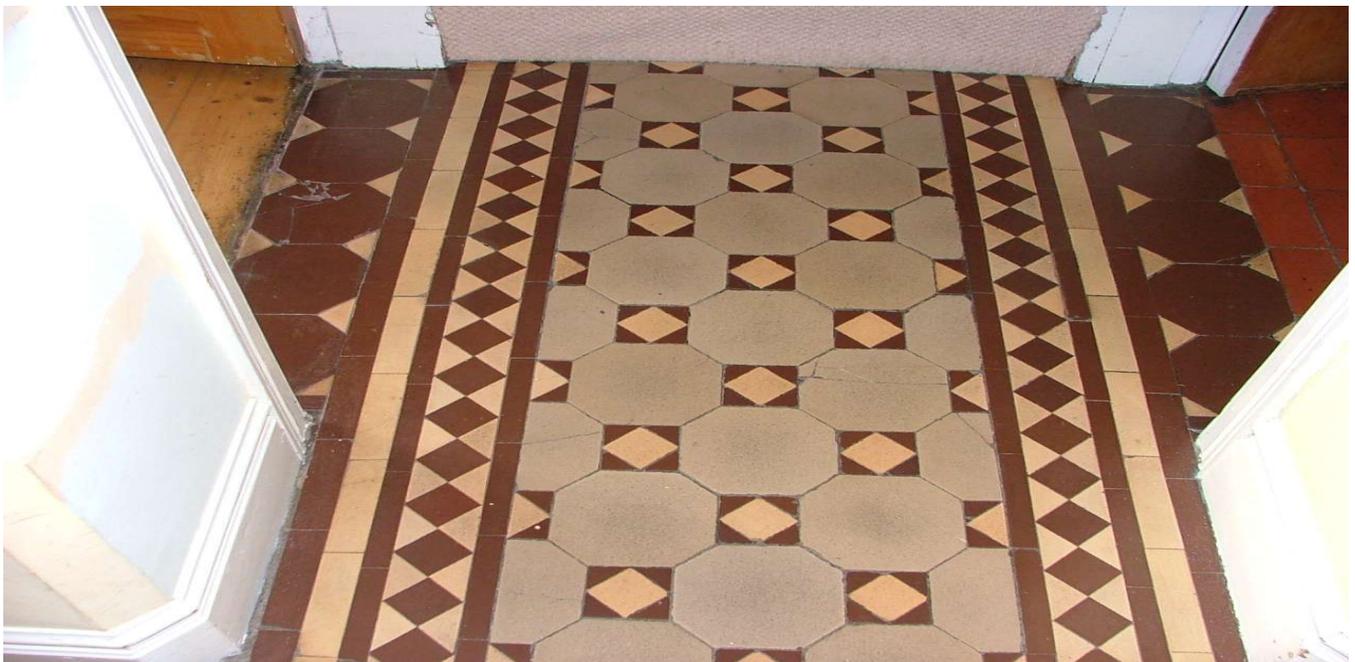
Note the threshold tiles in this before pic.

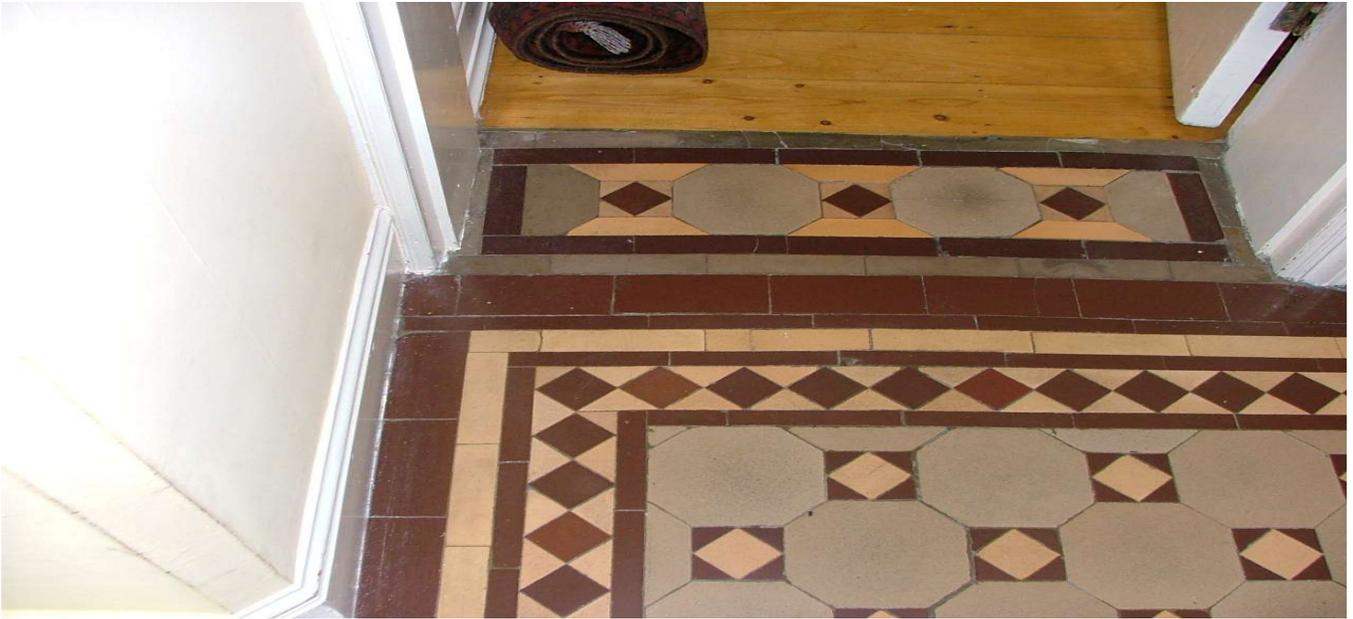
Badly fitted threshold tiles = out of synch with main floor.

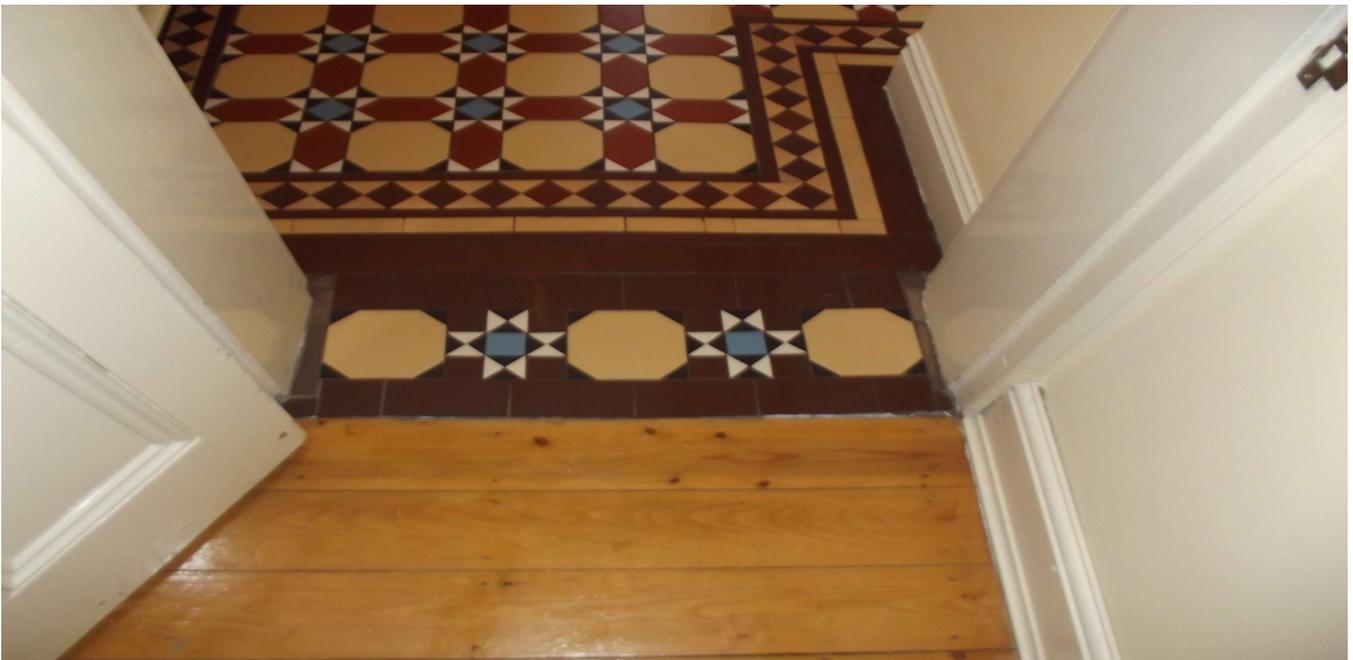
Re-tiled threshold linked into the restored floor.

The thresholds have all been lifted & replaced using new tiles; any damaged tiles in the border were replaced using original tiles cut down from the main floor tiles or from our stock of original Victorian tiles.

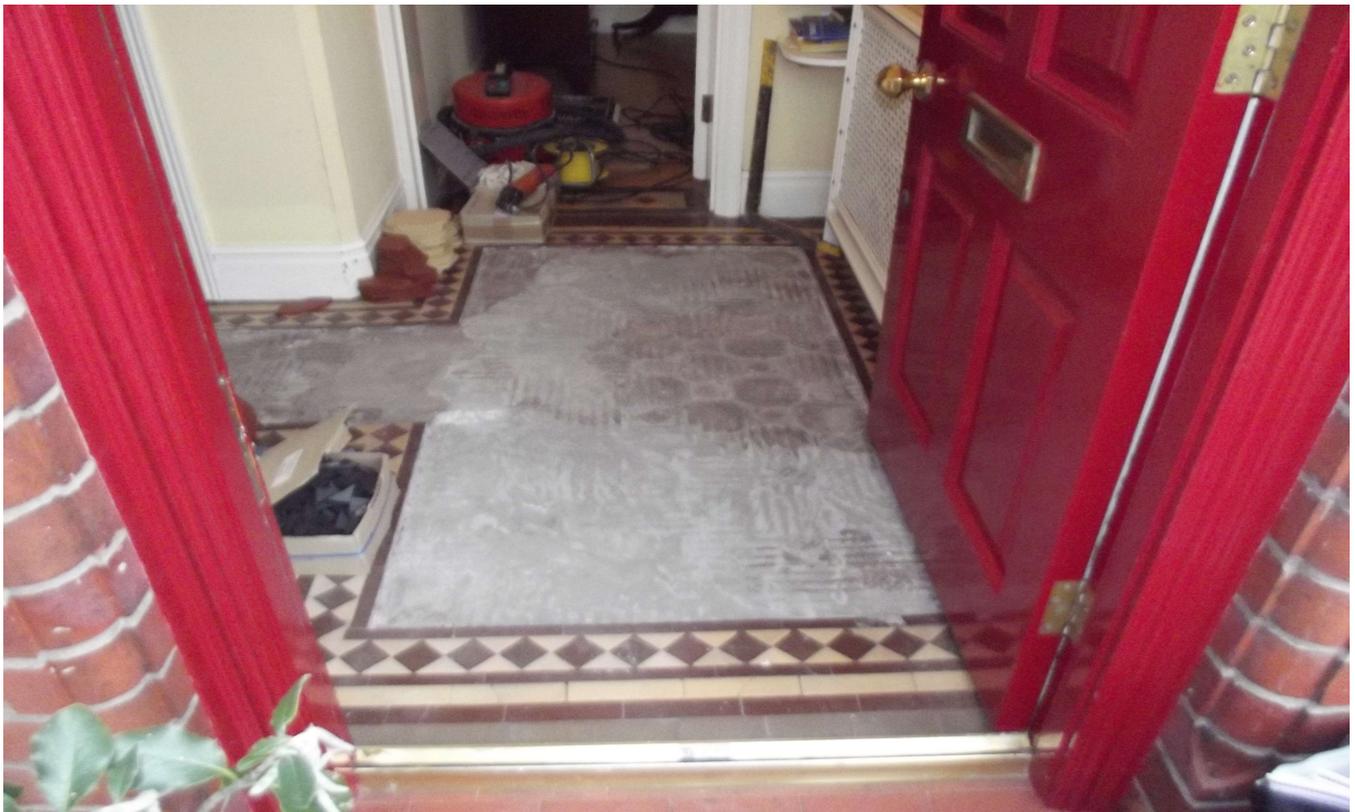
Main field tiles lifted.

On this contract the budget did not allow for the whole floor to be lifted, so a compromise was reached the main field pattern tiles were lifted and a new pattern was fitted.

To remove the old cracked and badly fitting tiles (some had lifted more than half an inch -12.5 mm above the other tiles) I employed 2 Exakt saws fitted with diamond blades & attached to an industrial Numatic double filtered Vacuum, this is a good precaution against dust inhalation as most Victorian tiled floors are fixed into lime screed.

The tiles are eased out after the Exakt saws have been employed cutting a line between the inner border tiles and the main field tiles, this lineal cutting breaks the connection between the border tiles & the field tiles and so prevents the border tiles lifting or moving when the field tiles are levered or eased with a hammer & chisel, the percussive action of the latter is not transmitted as it would be normally because the screed has been cut using the Exact saws.

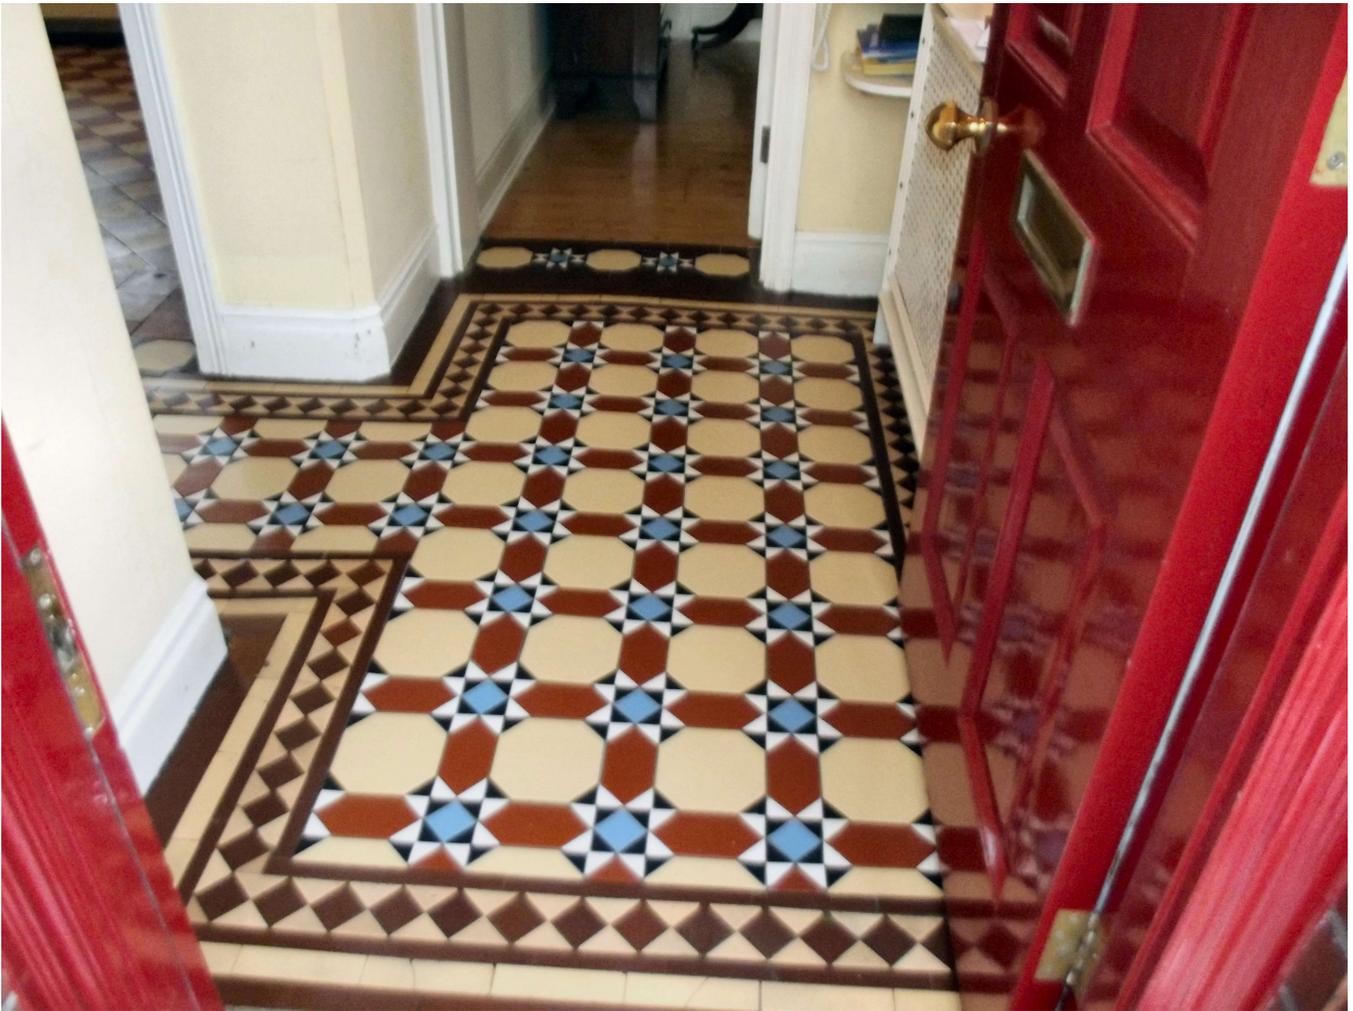
Torrison C pattern main field tiles and cleaned & sealed floor.

View of floor showing replaced thresholds.

The New tiles fitted are from Olde English (made by French firm Winckelmans) the pattern is Torrison C.

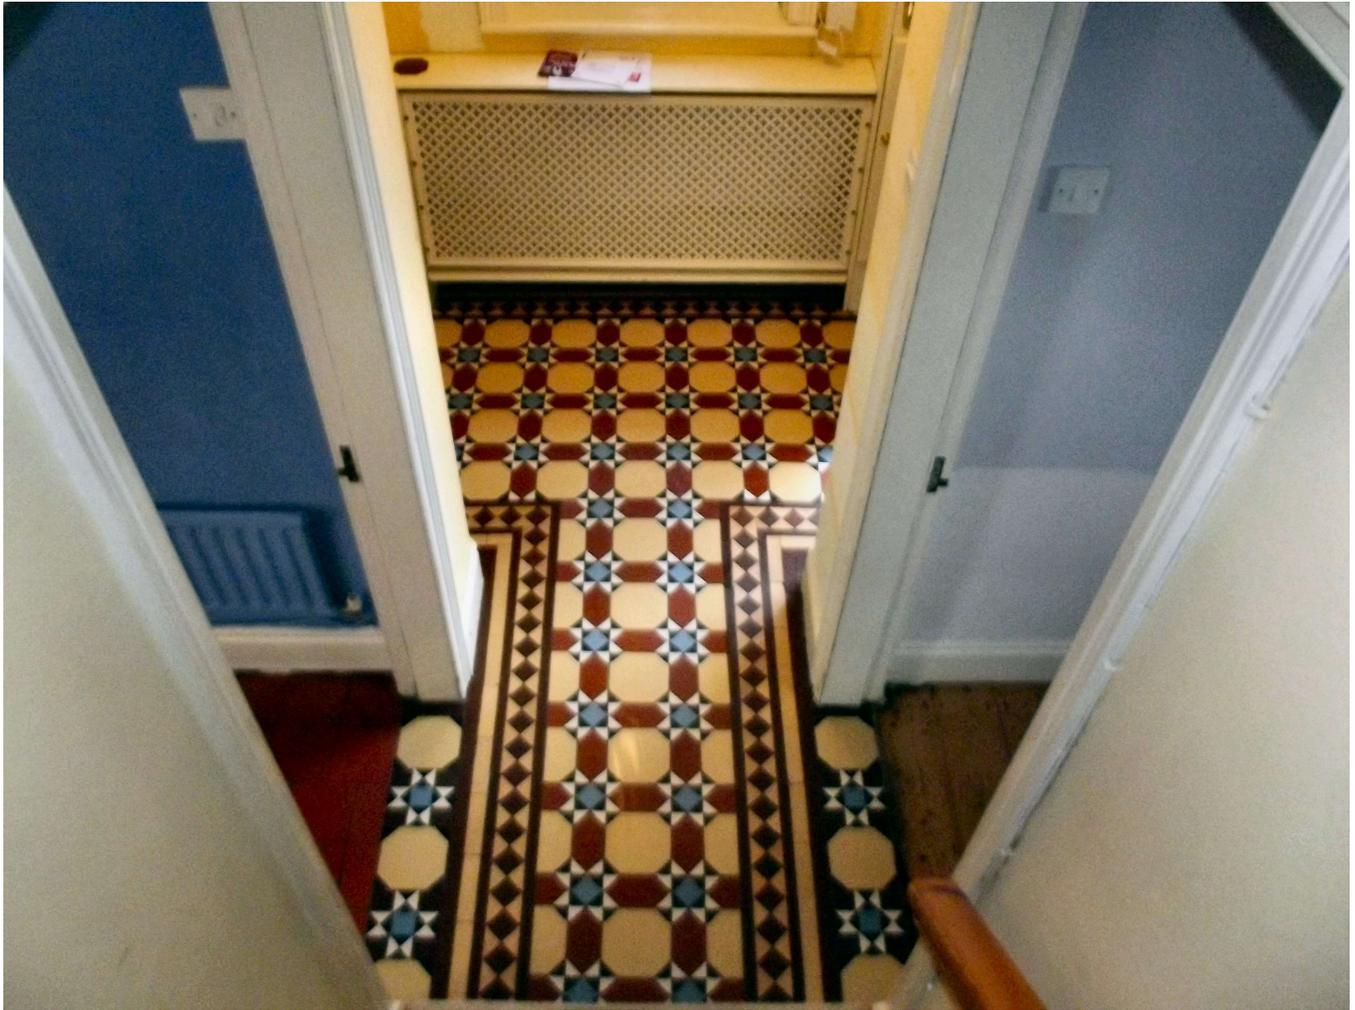
Stair view of floor showing transformation of floor.

KeraKoll H40 Eco Marmorex was adhesive used as it allows for adjustment and sets in a reasonable time also has a fantastic temperature tolerance.

Grout was in Fugabella eco flex 44 cement grey.

Sealing was carried out with Dry-Treat Stain-Proof.
