G&S DeSouza. Late Victorian Encaustic & Geometric Floor.

Small domestic hall floor, the tiled floor was intact & sound for the most part, some usual damage at the kitchen threshold = cracked & loose tiles, scattered areas throughout the tiled floor most notably at the foot of the stairs which again is a usual spot for damage as it has had heavy footfall over the last century plus.

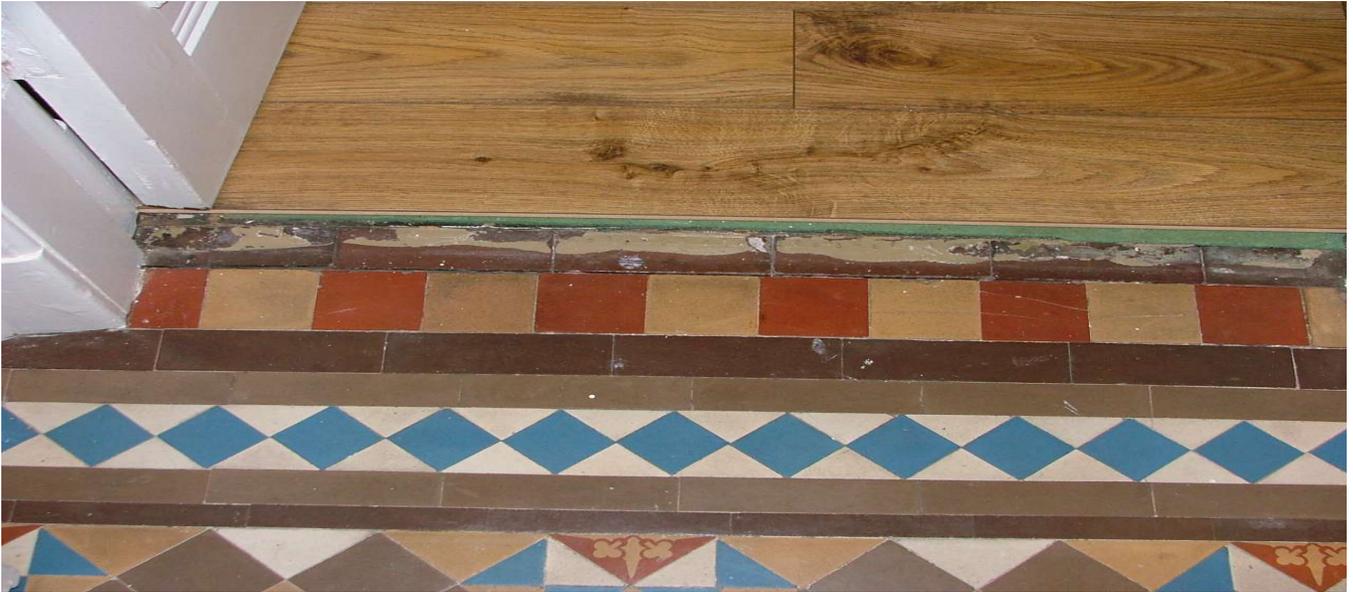
For some reason the thresholds on this floor were not the same and they were incompatible with the main field & border.

1st threshold set in colours and pattern out of odds with main floor.

I lifted the two thresholds and re-set with a design which was in tune with the main floor.

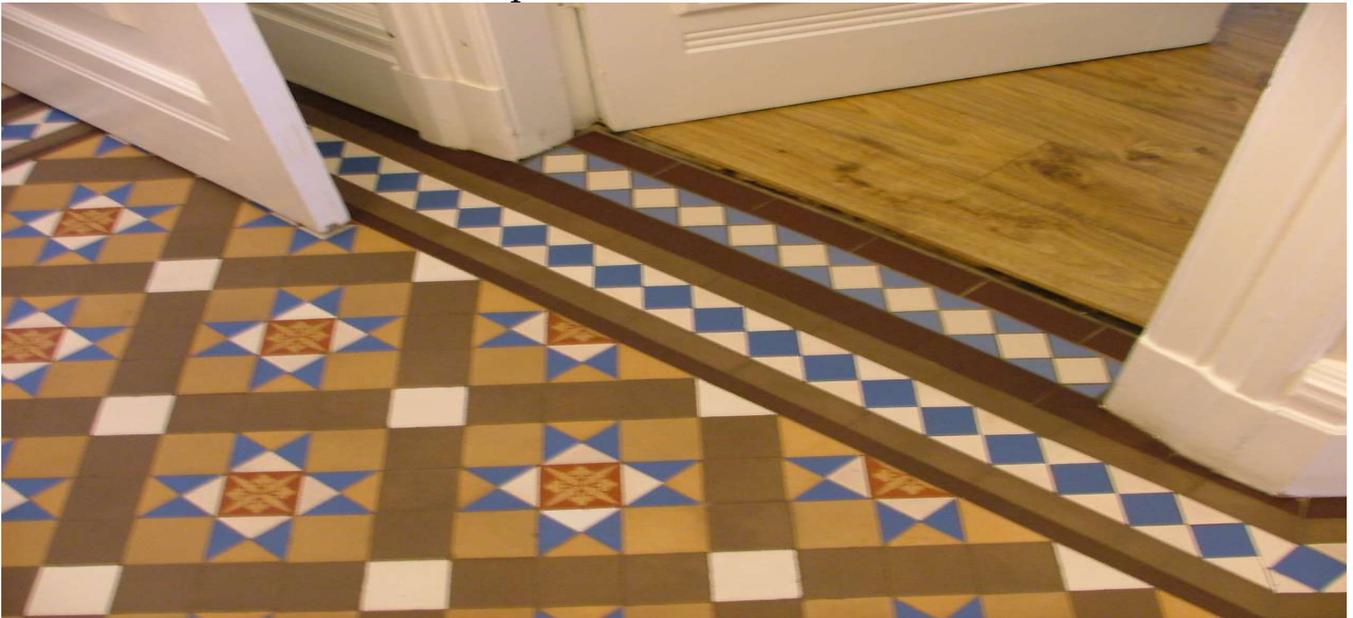
New threshold.

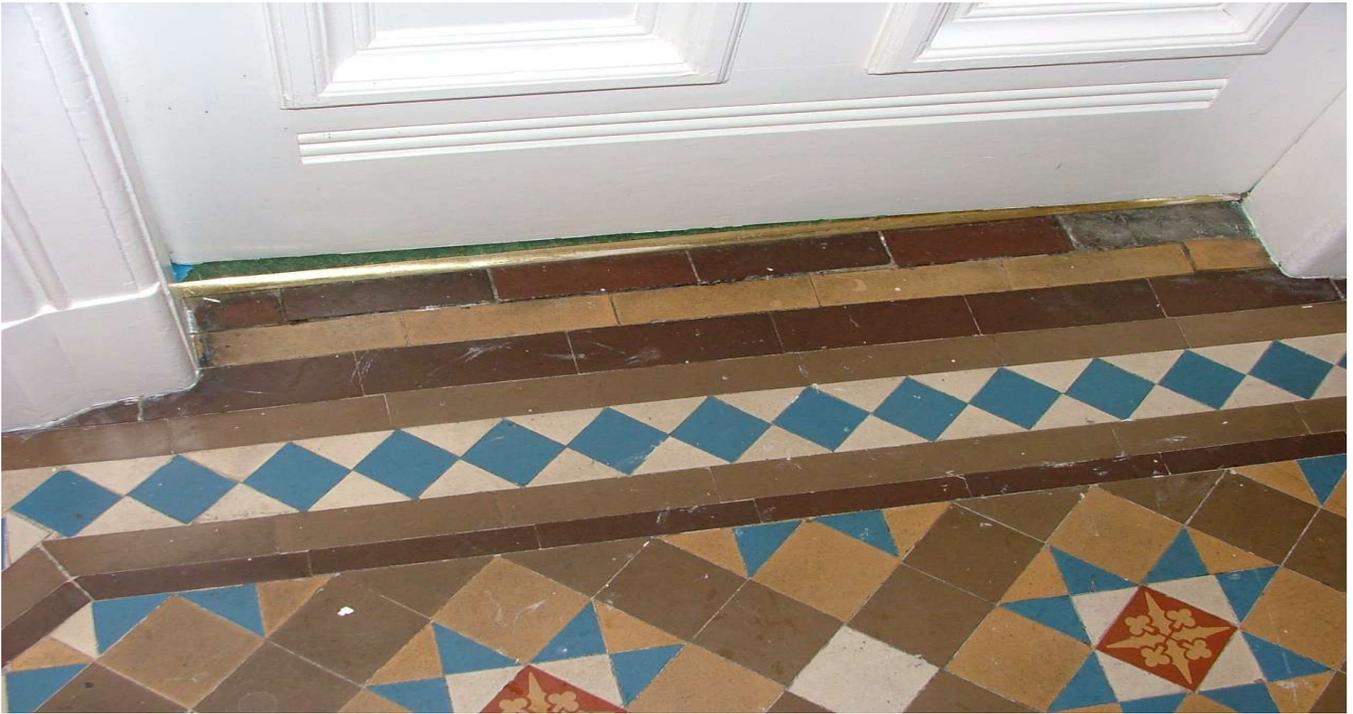
2nd threshold before being re-designed.

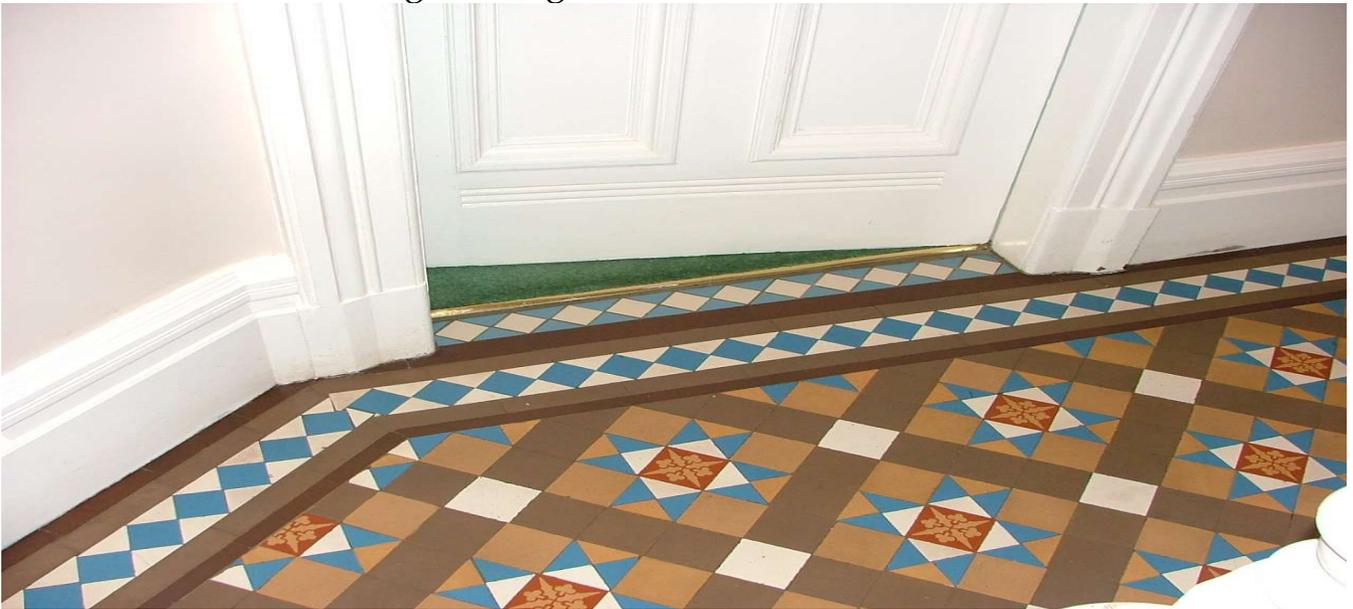
New threshold design. Olde English Repro tiles were used for the new thresholds, re-claim tiles from stock were used for repairs and a few tiles from Craven Dunnill tiles of Jackfield.
