Restoration of Smalti Mosaic & Marble flooring, Project carried out at:-  
St Thomas Church Douglas Isle of Man. Grade 1 listed.

Ref: The Restoration of the Mosaics in the parish Church of St Thomas, Douglas, Diocese of Sodor and Man (Isle of Man) by Mr Steve Sinnott of The Heritage Tiling and Restoration Co., Seaforth, Liverpool.

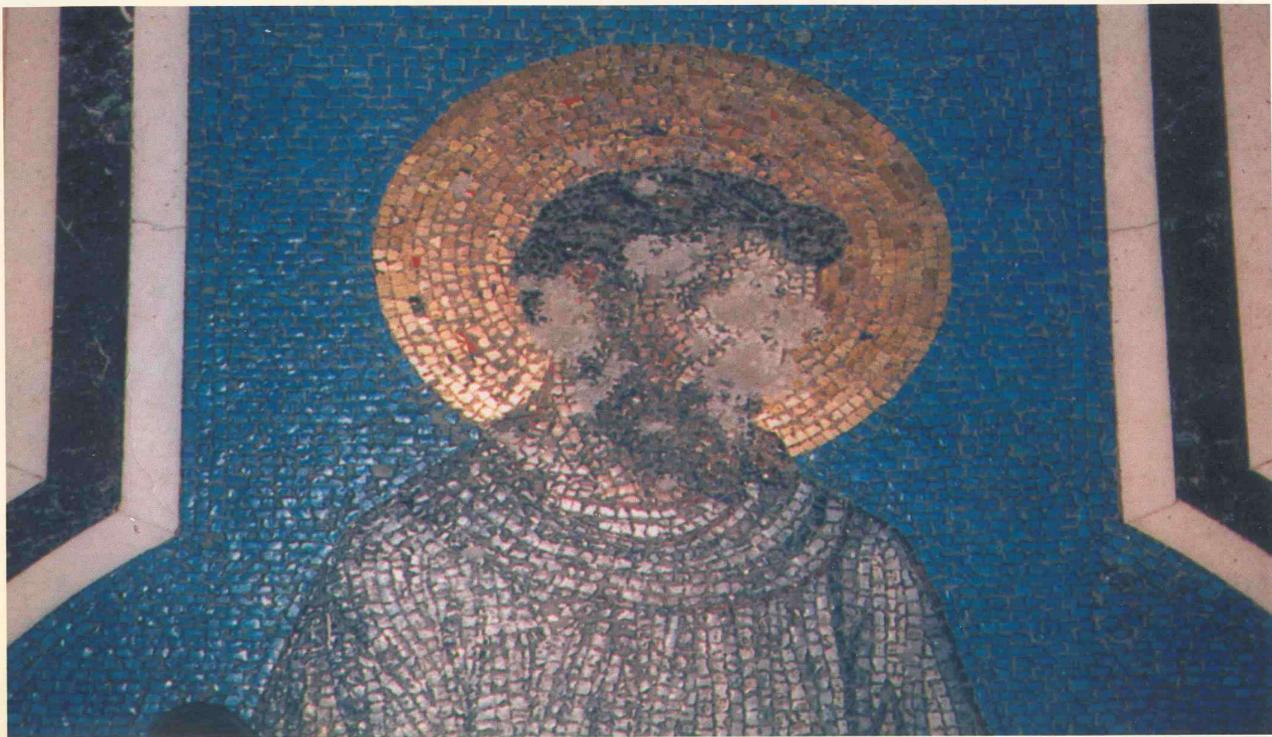
The main focus of our restoration contract was the full size figure of St Thomas depicted holding the a representation of the church in his arms, the figures face had been obliterated , to stop further damage the face area had been filled in with car body filler , white plaster & poly-filler! unfortunately not one photograph of the saint could be found, I worked out the general look of the saints face based on the hundreds I had seen and depicted him as being somewhat mournful as that is the typical expression of most saints faces I have seen, not seen a happy or smiling one as yet !

I obtained some of the replacement Smalti mosaic from Rob Riley a great mosaic artist in his own right and the rest was ordered via Edgar Udney & Co London UK, who stock a wide range of various mosaic materials & tools. The saint and other examples of mosaic were in the church chancel. The main pieces after the Saint are set square & spear, an Arab sailing boat, and the Alpha & Omega.

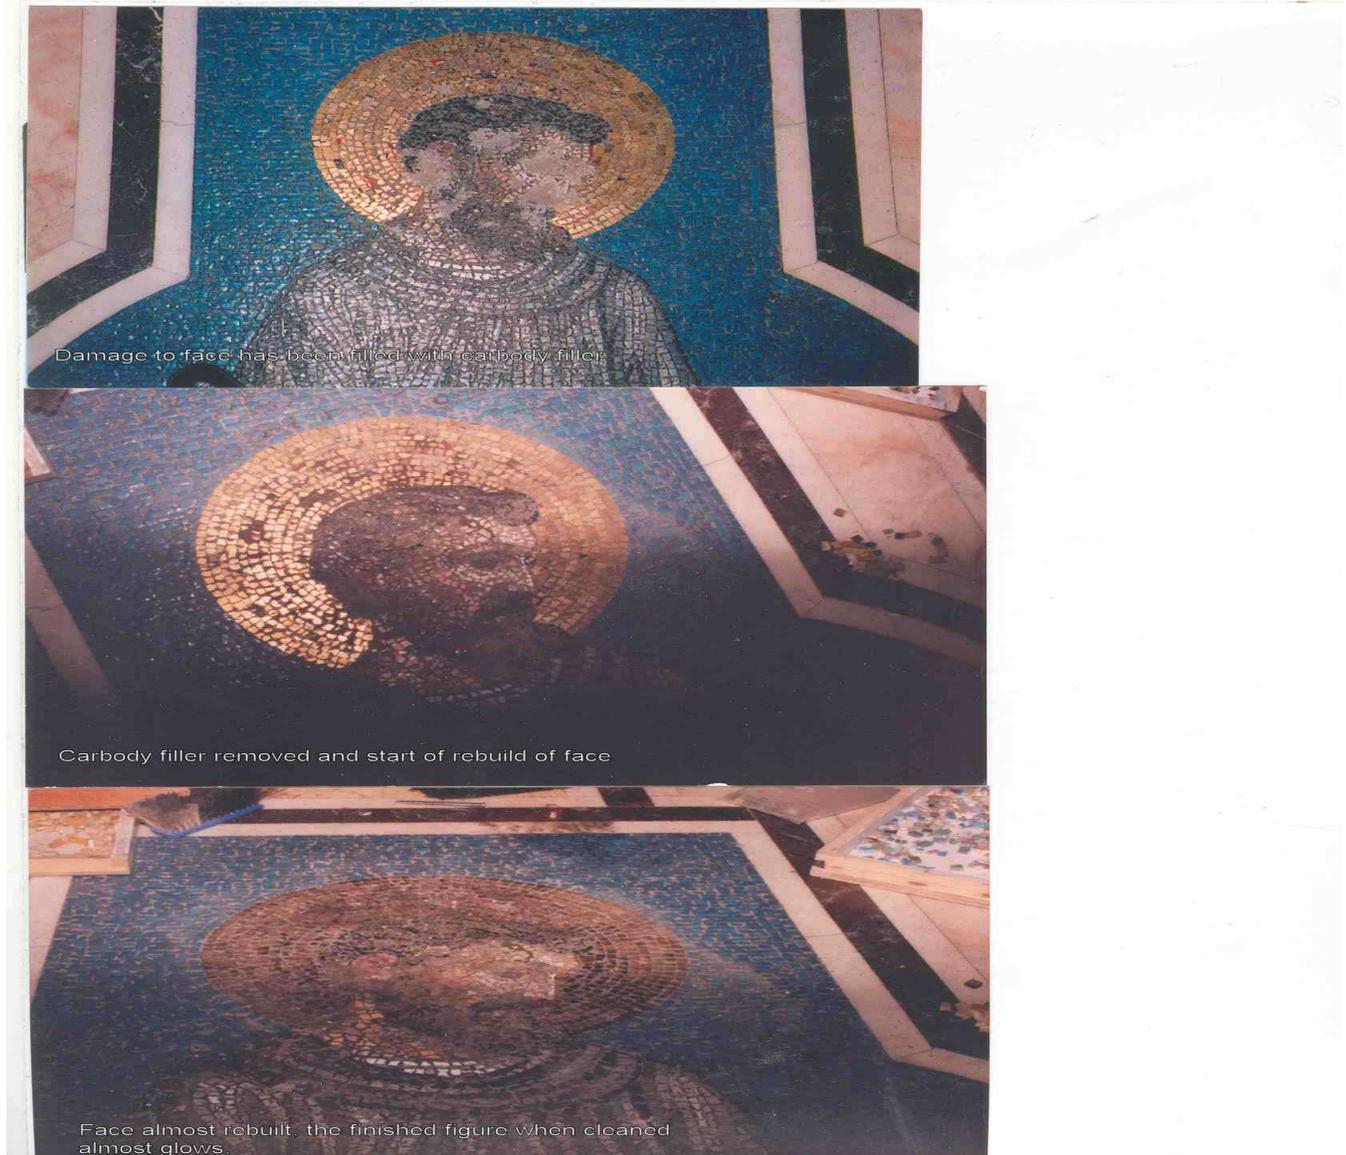
Restoration stages of the Saint's face.

The Saint's face and other damage took me approx 9 hours to complete and the damage to the other mosaic pictures took another day in total.

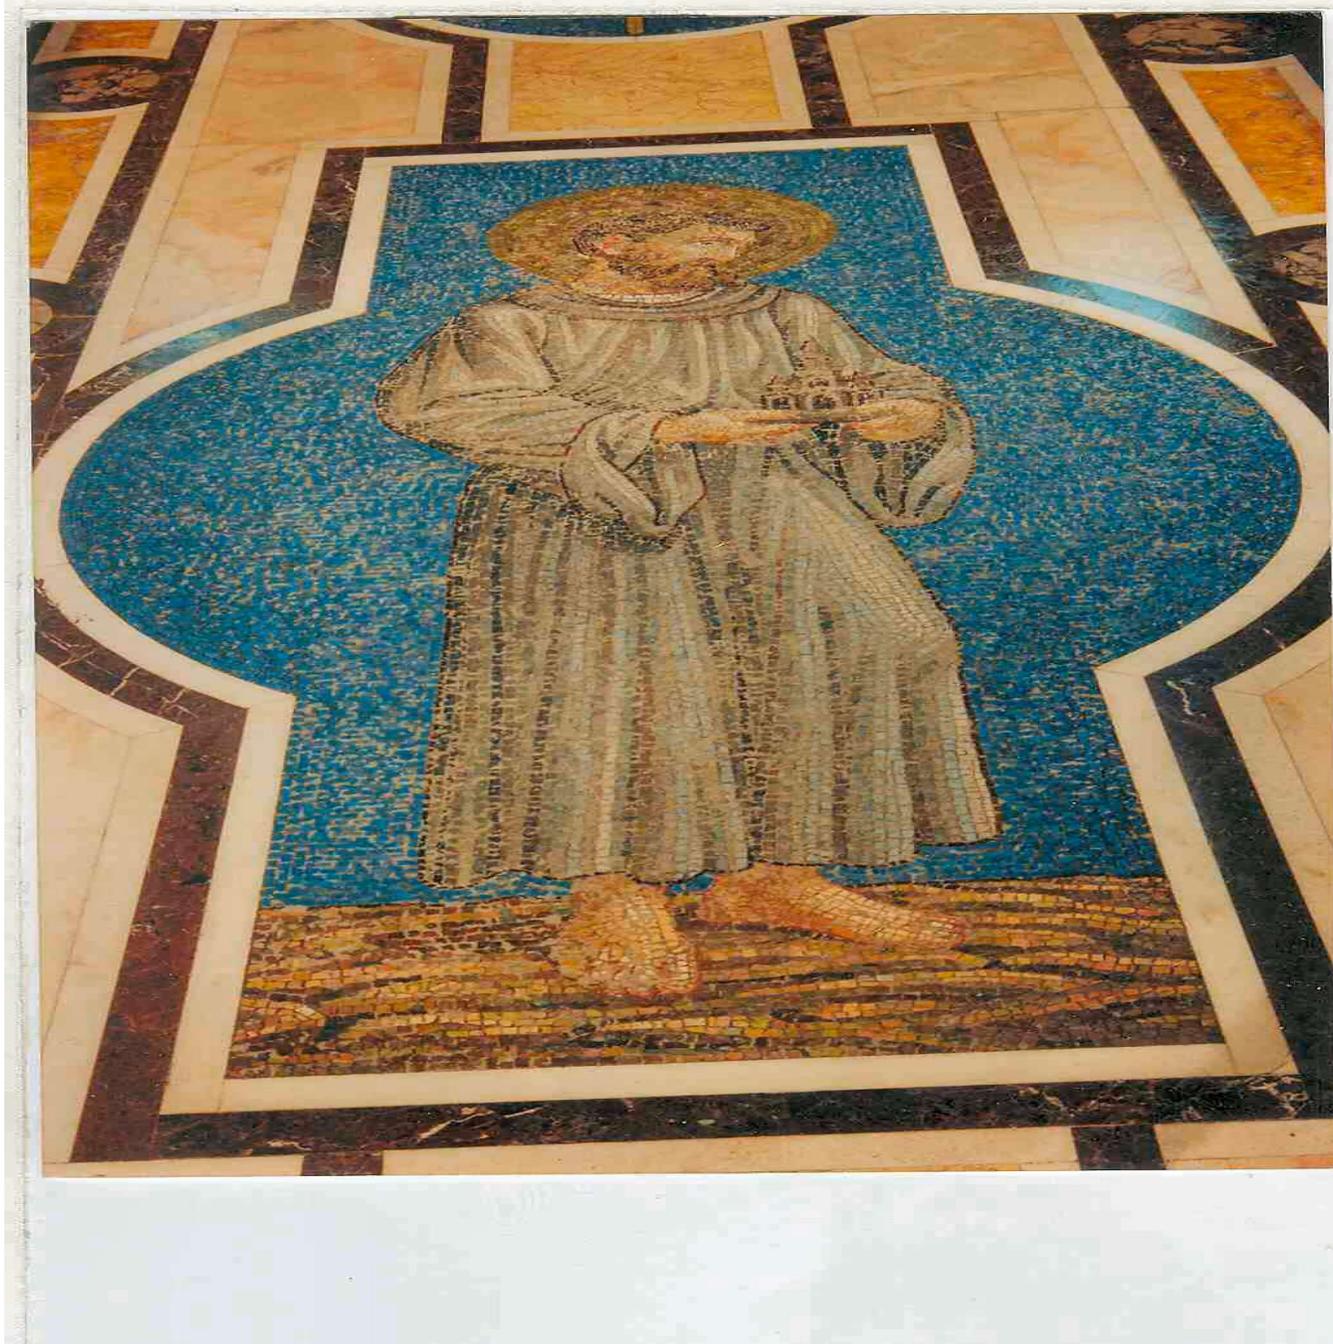
St Thomas Smalti Mosaic restored.

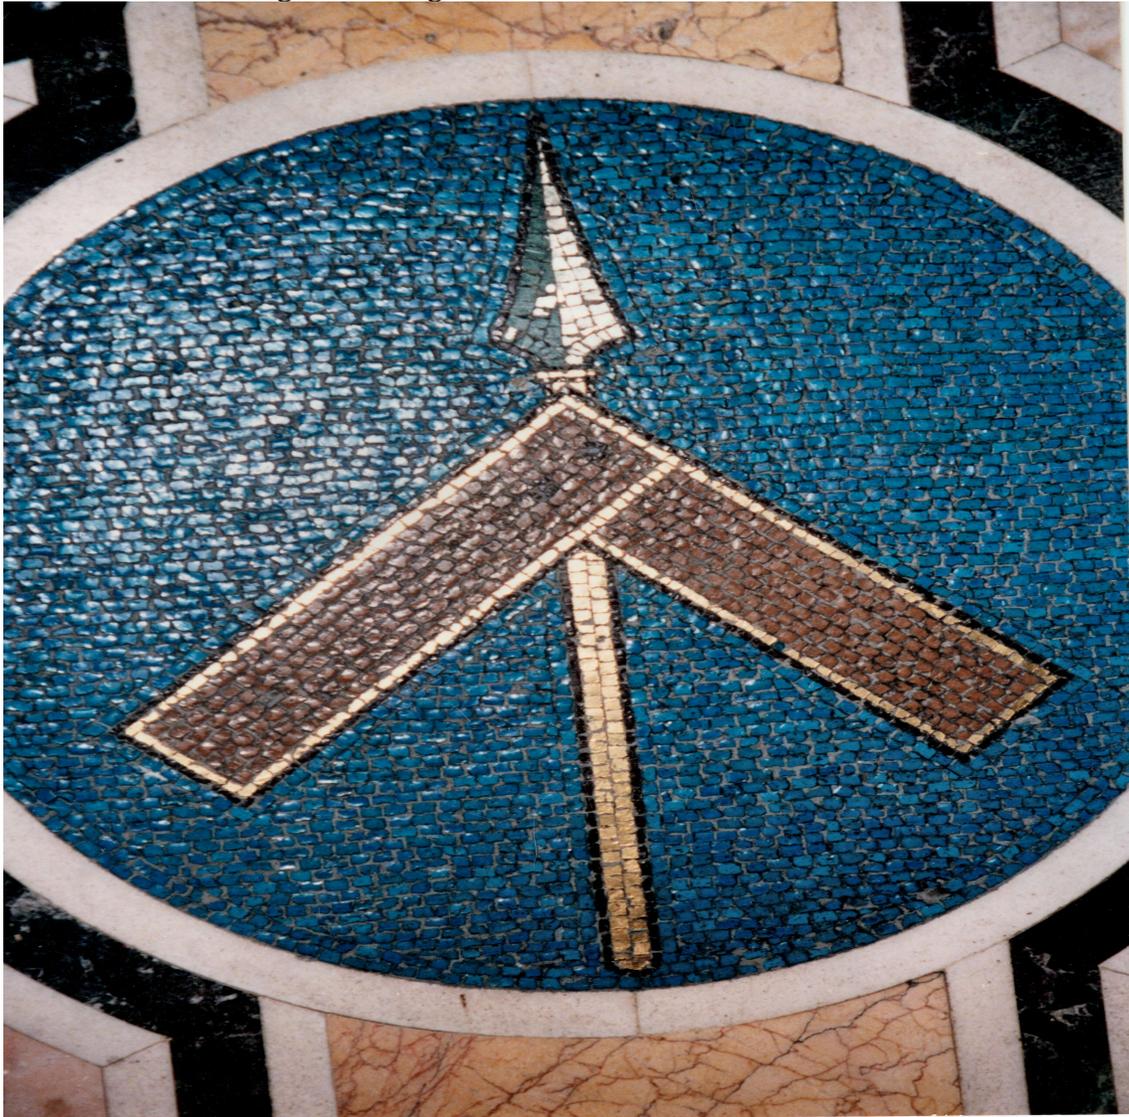
There was damage to the gold leaf mosaic and other sections in this roundel.

Set Square & Spear mosaic shown here fully restored.

The Set Square & Spear mosaic roundel above St Thomas is of interest because the Set Square represents St Thomas as a builder of Churches and the Spear his martyrdom when he was killed with a spear in India.

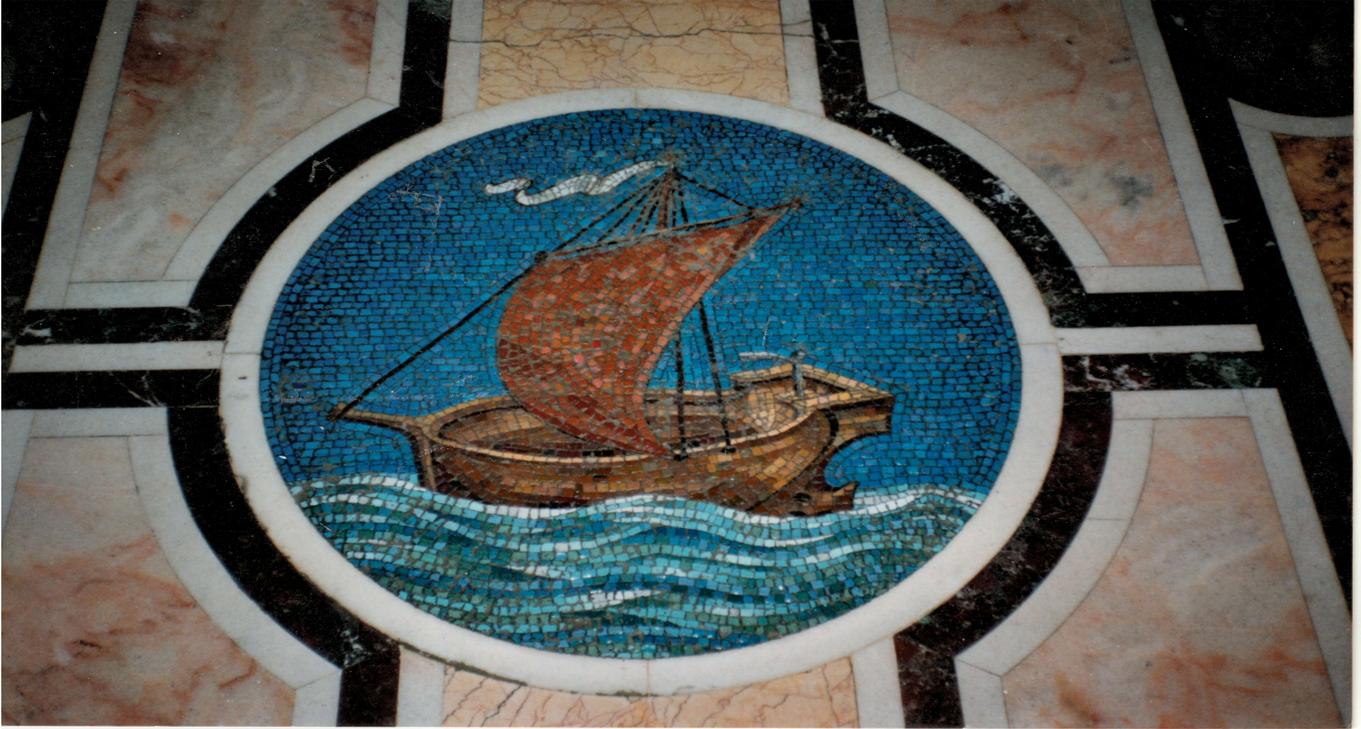
The Arab sailing ship represents St Thomas upon his journey's as a missionary the sail of the ship was very badly damaged and had lifted away from the bedding screed, the back ground was also loose and pieces missing from that also.

Arab sailing ship Smalti mosaic fully restored.

The Arab ship is shown here as fully restored which involved cleaning with a low rpm cleaner and sealing over a whole day to allow the coats to dry properly and bond correctly to the preceding layer, more coats than usual were applied so that the mosaic would be able to withstand the rigours of daily foot traffic & cleaning etc.

I also used a flexible based adhesive & grout to give the mosaic a better chance of surviving another century.

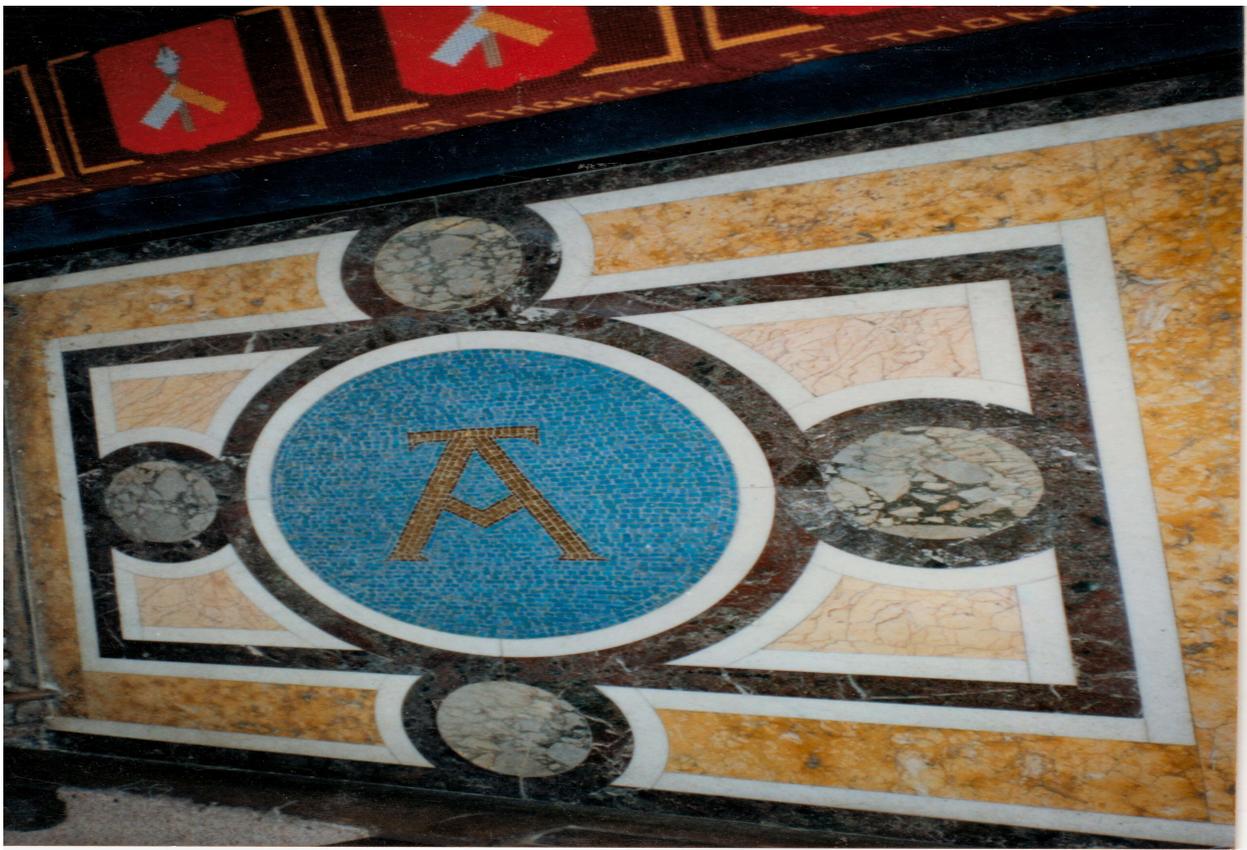
They had the least amount of damage but they had sustained some, the main floors that the figure & roundels are set into are fine Italian marble, the work was striking and I enjoyed being able to restore the Saint and the rest of the flooring it is always a pity when the craftsmanship of a long dead artisan is covered up with carpet, sadly even some of our projects have been covered with carpet not because our work wasn't good enough but to preserve the flooring! Personally I see little point in paying for work to be carried out and then pay again to cover it up.

Alpha Symbol fully restored.

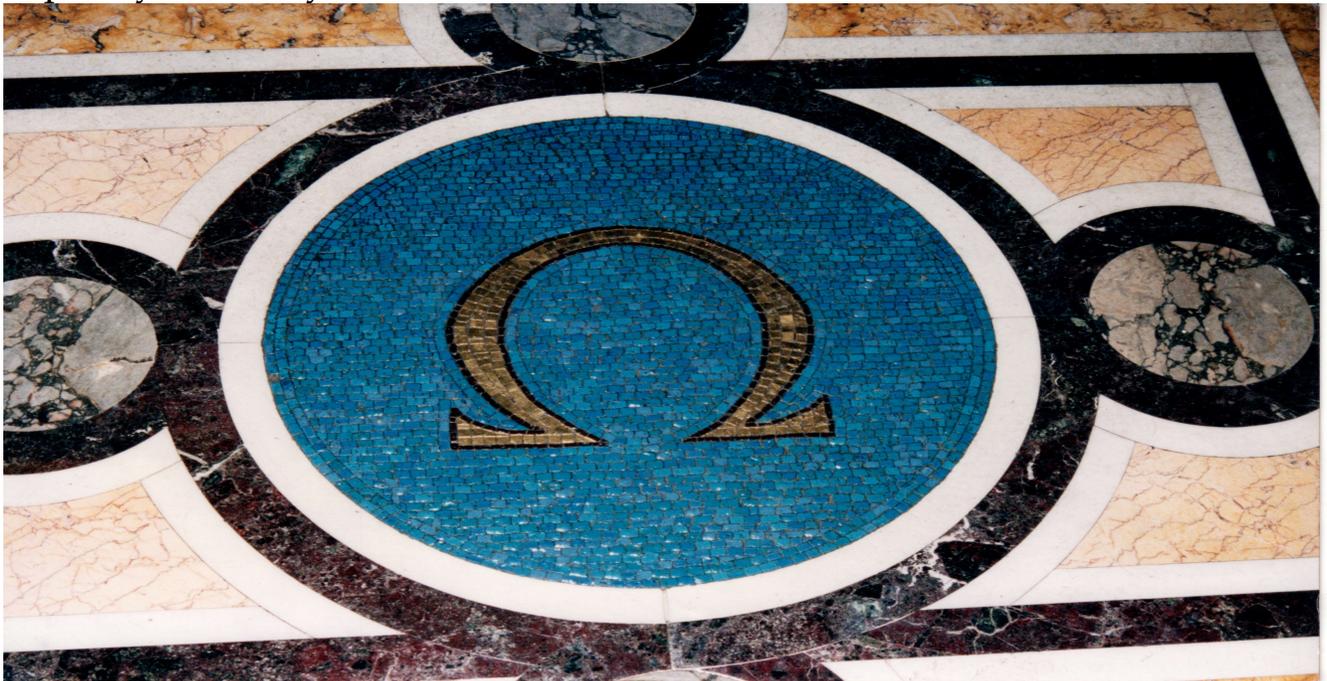
Omega symbol fully restored.

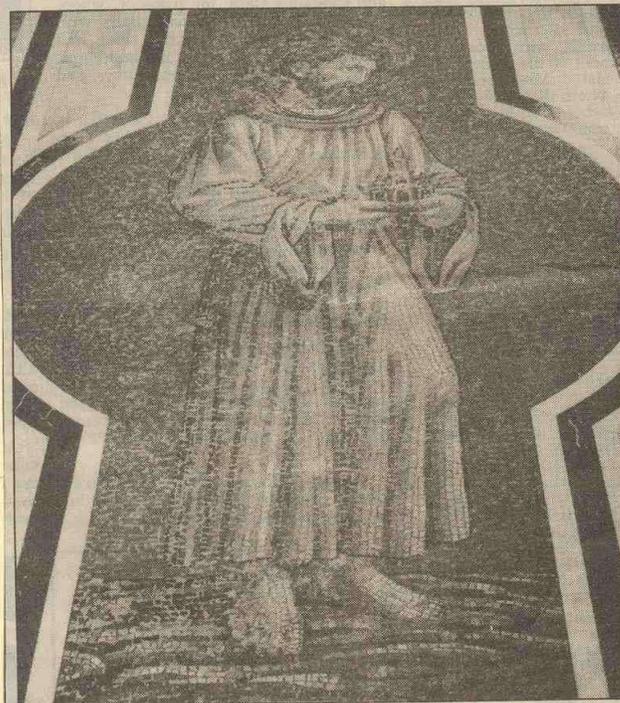
Saintly saving: the restored mosaics (1095224)

'The face was completely removed and had been filled in with white plaster to try to protect it from further damage. St Thomas's cloak was also damaged.

'At the bottom of St Thomas was a circular mosaic representing his missionary journey. The sail of his ship was very badly damaged.

'The set square and spear were not as badly damaged as other parts, but it had to be restored.'
