St Thomas More Church Leicester 1996 Re-order: Our contract was to restore damaged original 1950's mosaic, replace flat stone floors. Replace steps produce a new mosaic.

Our Co was called in to assist in the Re-order of the above church which was built in the early 1950's the Church needed to be up-dated and also have some of the fittings replaced = stone floors & steps which had been originally fitted with a soft marble and had become cracked & pitted = un-safe .

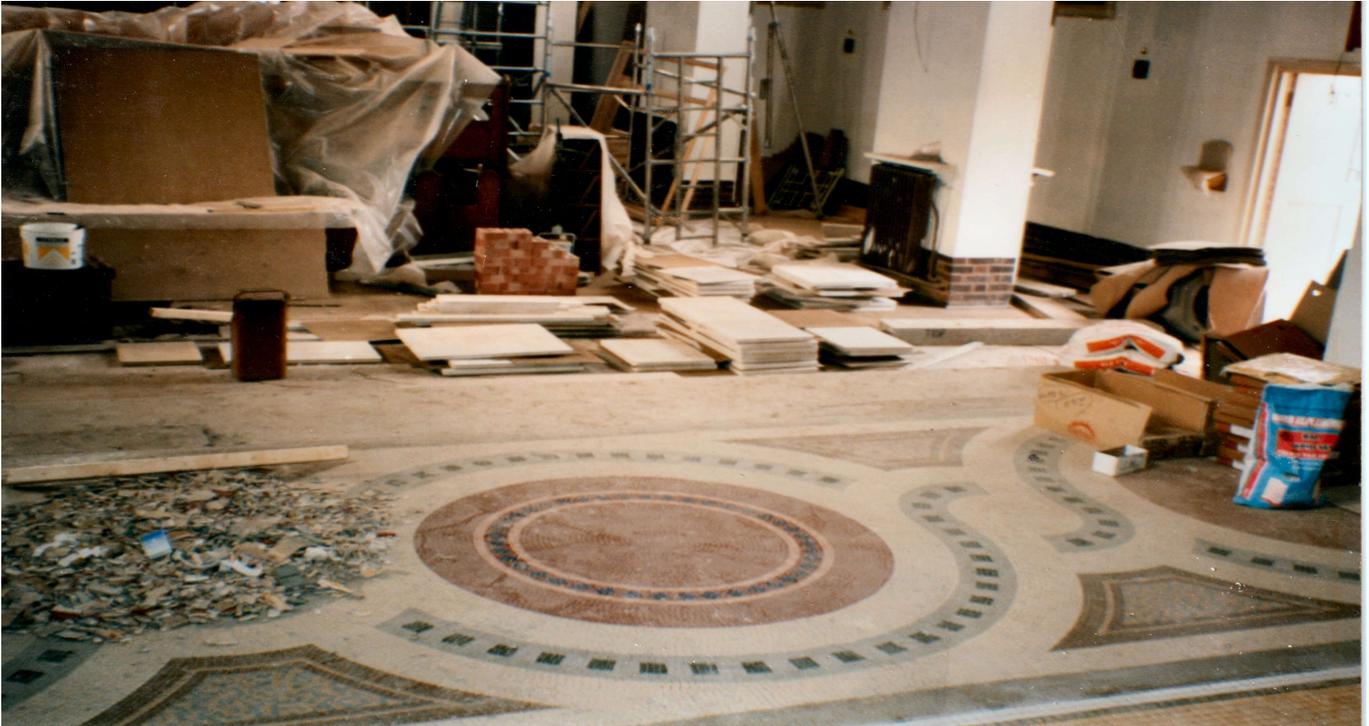
Start of project in the background is the section we installed a new mosaic.

Our Co installed a new mosaic and the Incumbent Priest (Irish) as per custom could have a design or decide on part of the installation. The final design which is a stylised variant of the Irish Ring Cross the colours and finished size were a result of talks with the client.

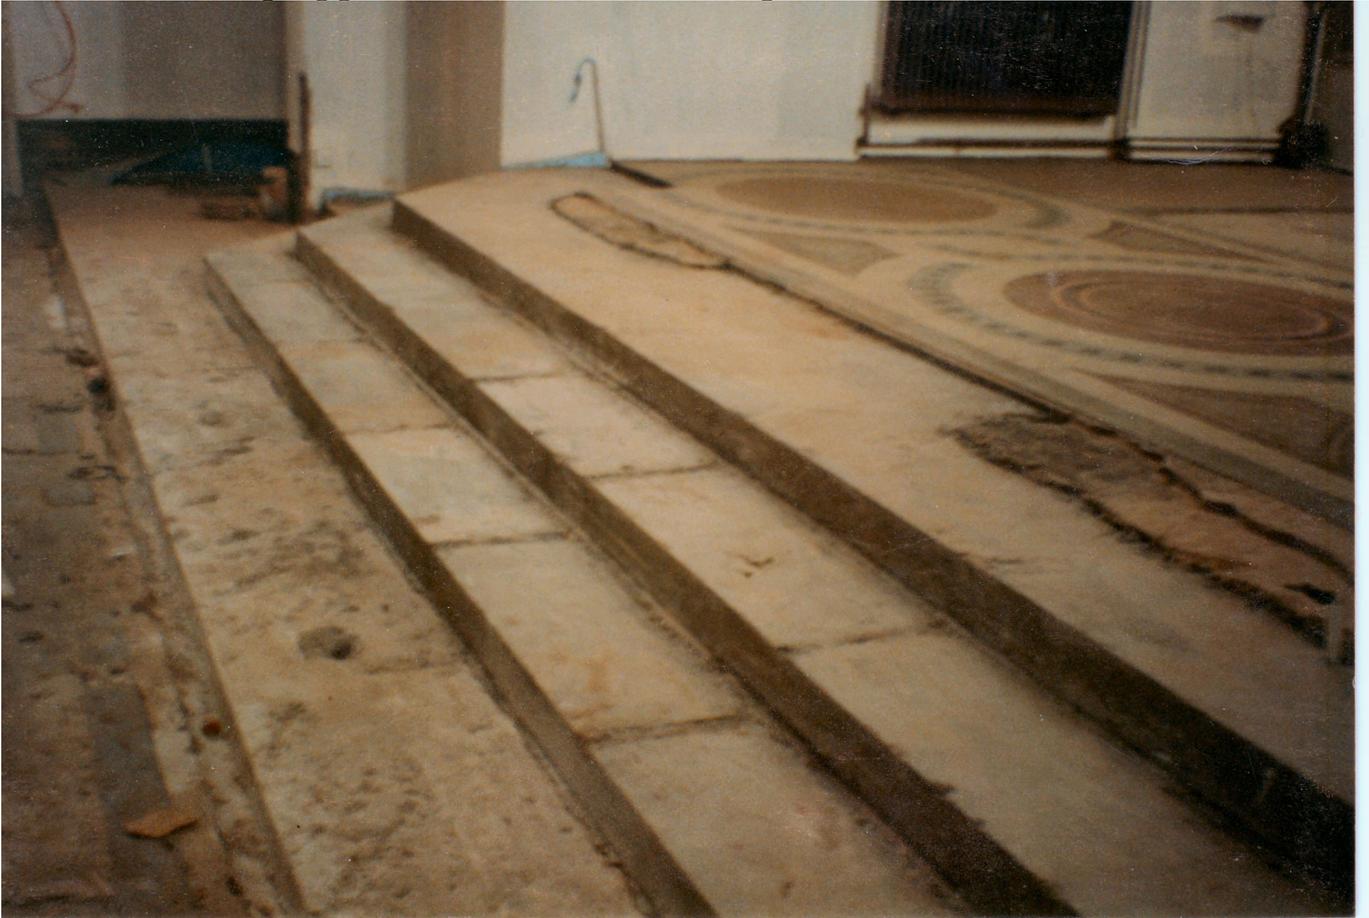
Original marble steps have been removed prior to prepping for new Limestone.

The Steps & flat floor area had all the old mortar and lipping ground down with diamond grinders.

The prep work took Heritage Tiling & Restoration more than a week before the areas were suitable to start re-laying the new flat stone floor /steps install a new glass mosaic etc.

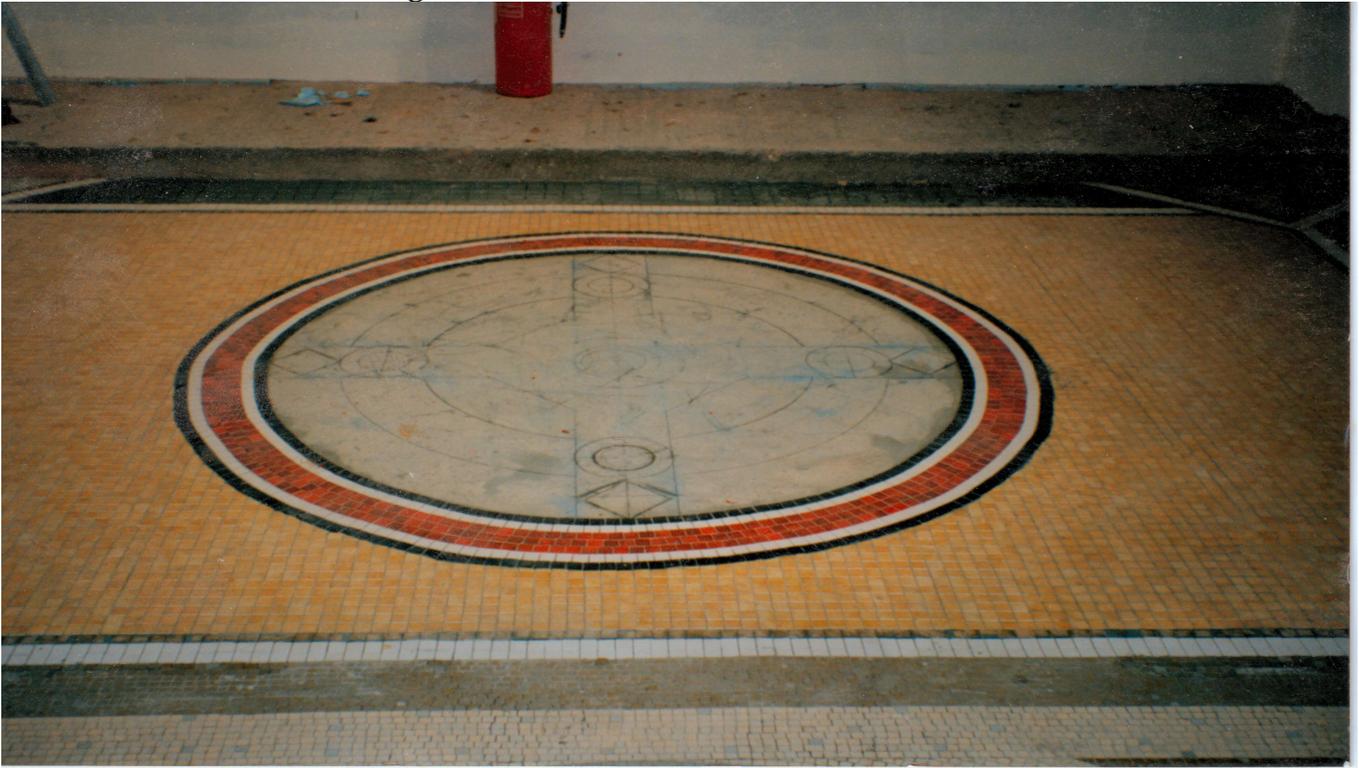
Picture below shows the new Celtic Cross as approved by the Incumbent priest, in various instalment stages.

The Cross outer circle was fitted first then the field tile fixed.

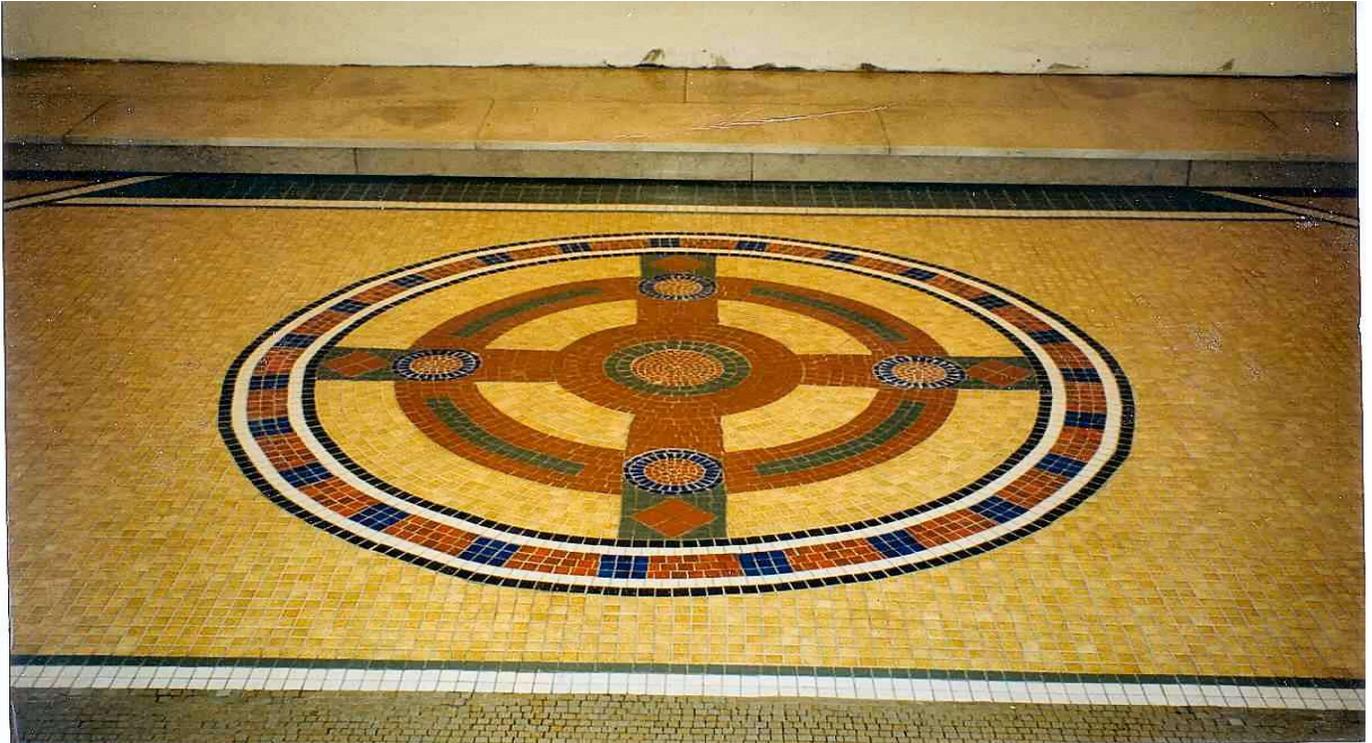
The Main design in colours chosen by the client.

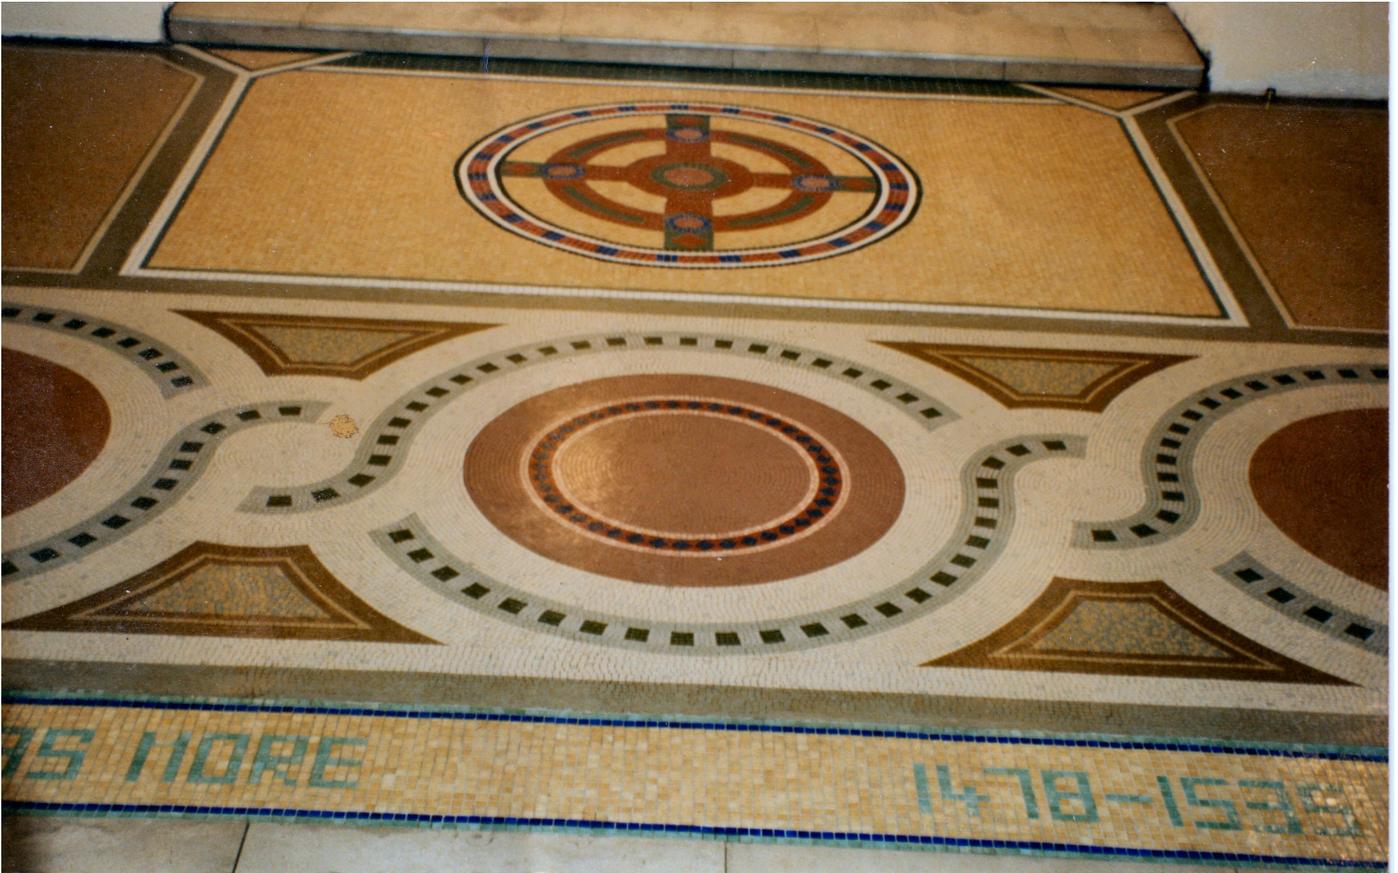
Below showing completed new mosaic design of a Celtic Cross above the original mosaic.

Design of the New Celtic Cross plus the rest of the back ground mosaic.

In all we installed more than 80 sq metres of new mosaic and repaired/restored various loose & damaged sections of the original mosaic.

Fore-ground shows the top step with parts of the legend = St Thomas More then his date of birth and death.

Below that are the new Limestone steps, in the back ground are the new Celtic Cross mosaic plus the complementary designed side & rear panels before rising to a raised new Limestone plinth for the Altar.

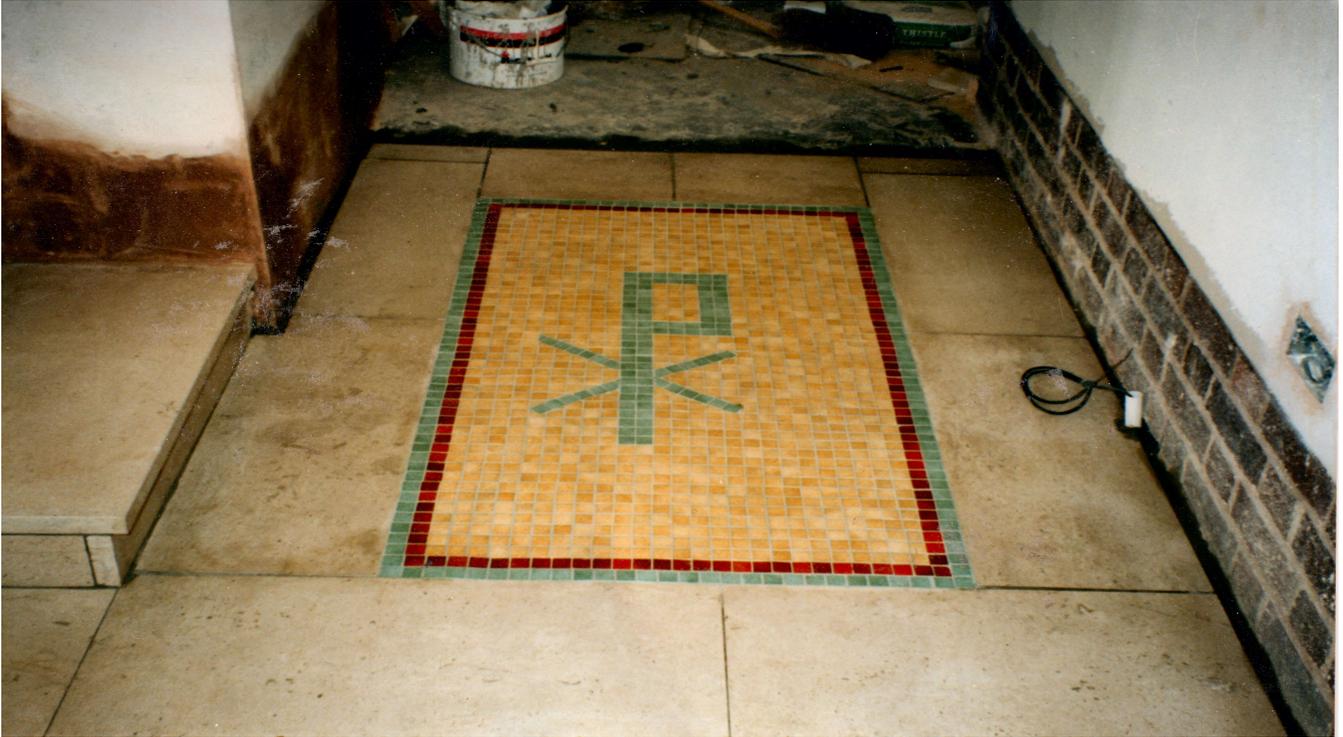
The New Chi-Rho glass mosaic.

We installed the new mosaic designs such as a Chi-Rho and restored the damaged areas on the original mosaic.

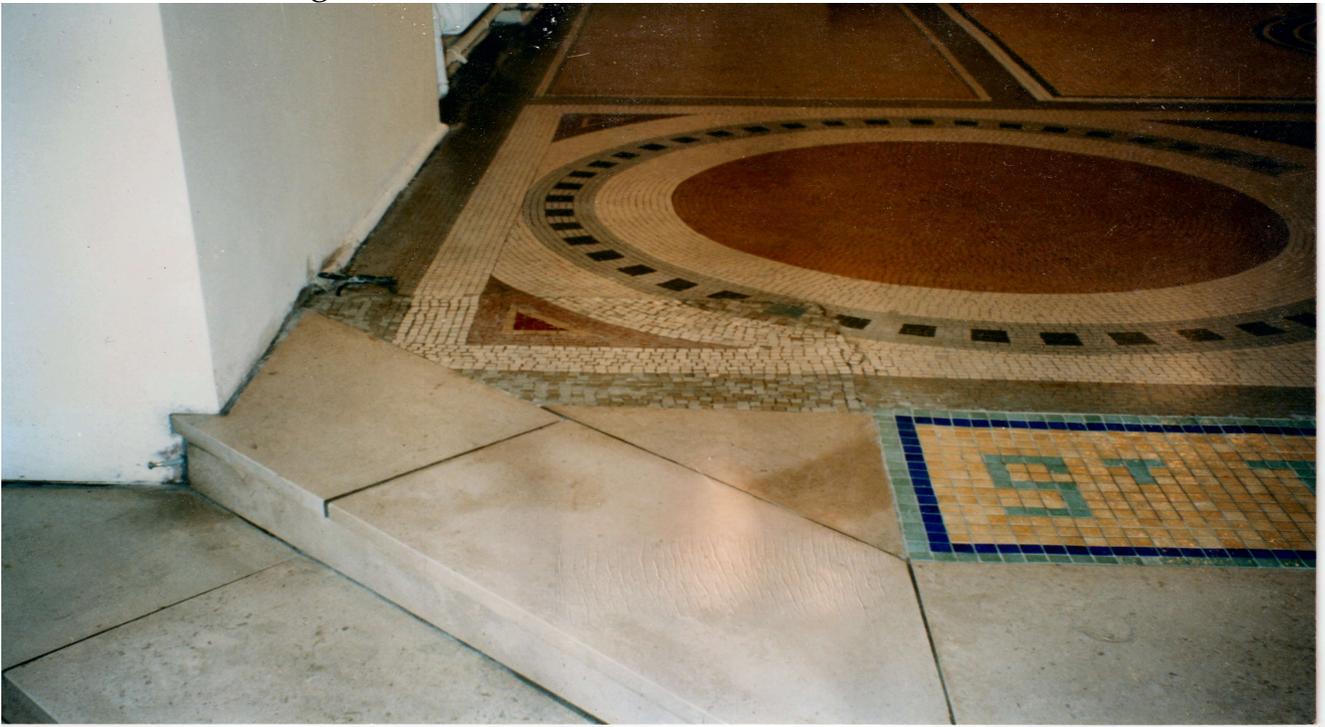
Part of the new Limestone steps original & new mosaic.

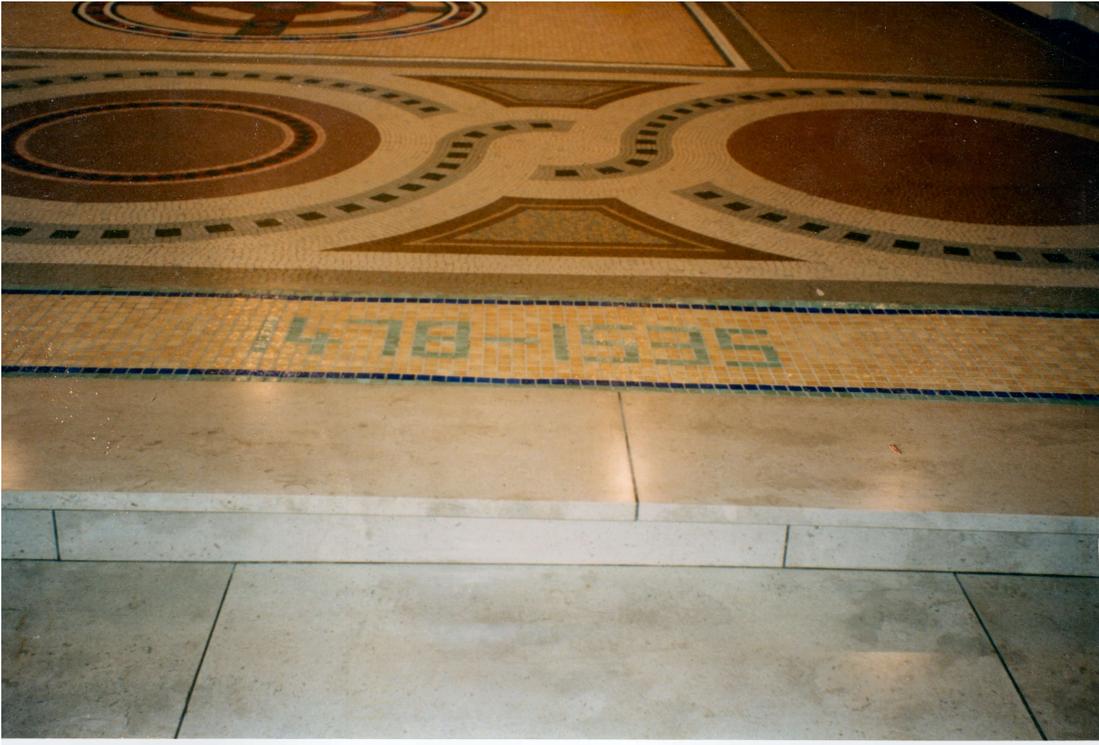
The picture below shows part of the new installed Limestone steps plus part of the mosaic inset dates, plus part of the flat stone flooring.

New Limestone steps & flat floor plus mosaic

After all the works were completed the various parts of the flooring = stone & mosaic were thoroughly cleaned and all the grout & mortar haze and dirt etc removed until the floor was spotless.

After drying out for a couple of days and covered to prevent any dirt etc to stain the clean floor, we then applied 5 coats of a water based sealer to all areas of the floor.
