Alderley Edge Restoration of a Late Victorian Encaustic & Geometric Tiled Floor.

The Victorian encaustic & geometric tiled floor on this contract was badly damaged in a number of areas most notably at the foot of the stairs.

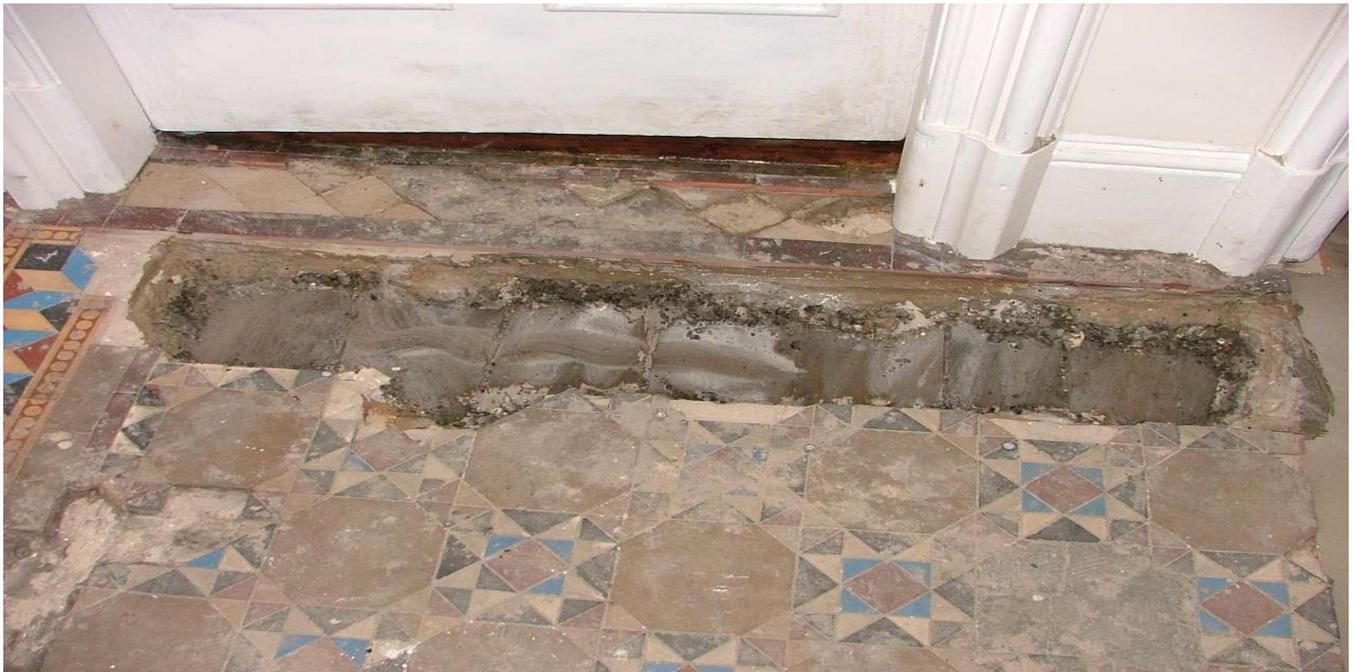
P6.

Section of in-fill being removed in front of dining room.

As can be seen here this section of infill links with the square section in front of the kitchen door.

Because of the amount of damage and the fact the kitchen thresholds tiles were missing I decided to use the remaining encaustic tiles and split them equally between the two thresholds = dining & kitchen thresholds I put black tiles in place for the missing encaustics, the clients declined to have new encaustics made as the cost for one mould and subsequent new tiles is costly. However the revised format blends well and does not look out of place.

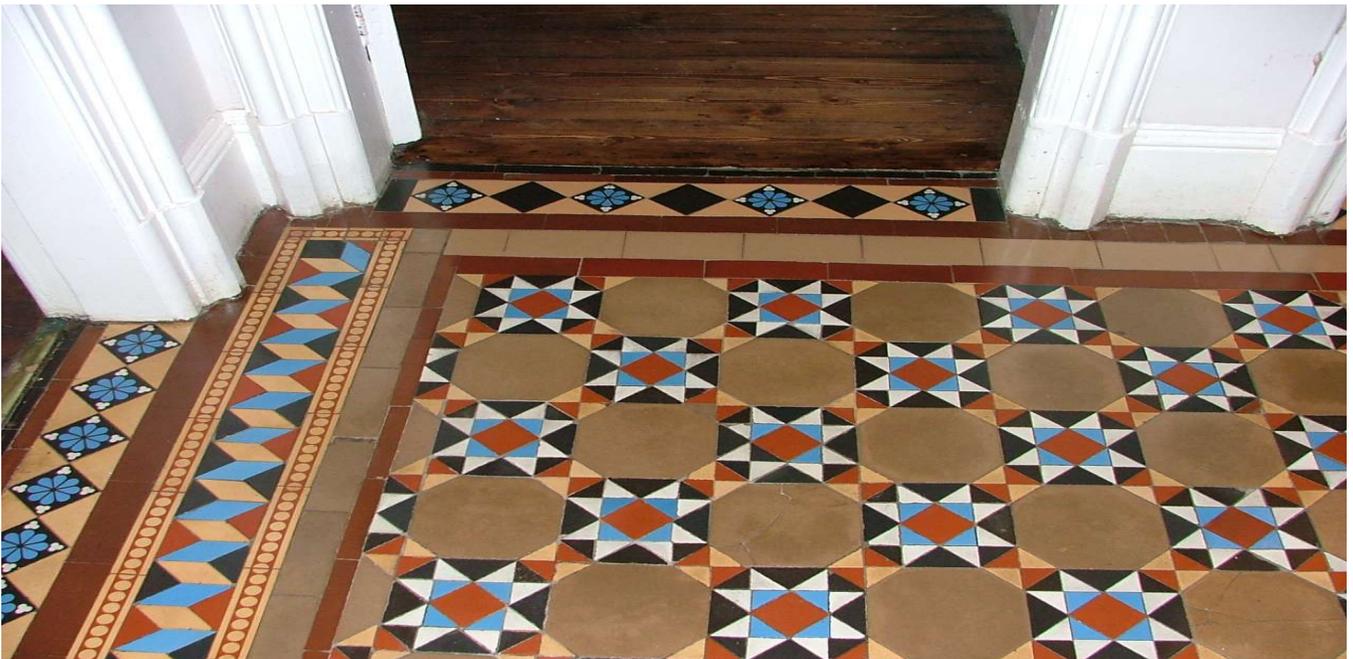
Dining room threshold with encaustics which are lifted to be spaced into the kitchen threshold.

Re-set tiles in both thresholds keeping symmetry & aesthetics of the floor intact! The remnant of the damaged border was lifted so that the tiles could fix the missing section on the right-hand of the floor = kitchen door section, the main field tiles were extended to fill in the missing border section and a red & oat tile band was fixed the full width of the floor which after cleaning & sealing looks to have been part of the original floor plan rather than a new addition.
